Progress Report

**Evaluation of Measures to Reduce
Wildlife-Vehicle Collisions and
Promote Connectivity in a Sonoran
Desert Environment – State Route
77**

Santa Catalina – Tortolita Mountain Corridor

Submitted by the:
Arizona Game and Fish Department
Wildlife Contracts Branch

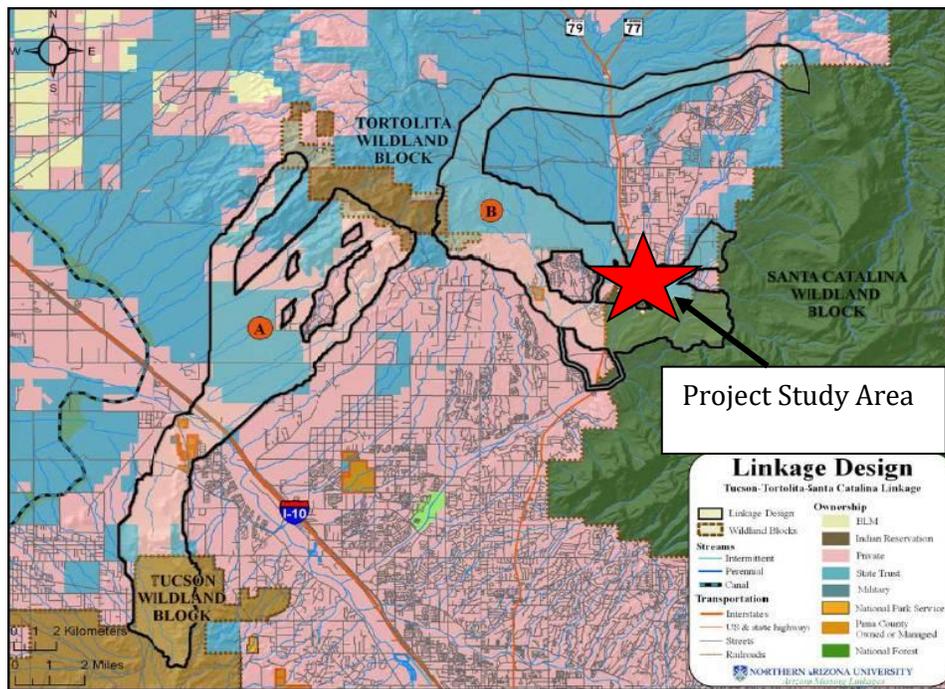
Figure 1. Least-cost linkage design for the Tucson, Tortolita, and Santa Catalina mountains and location of study area. Map from Beier et al. 2006.

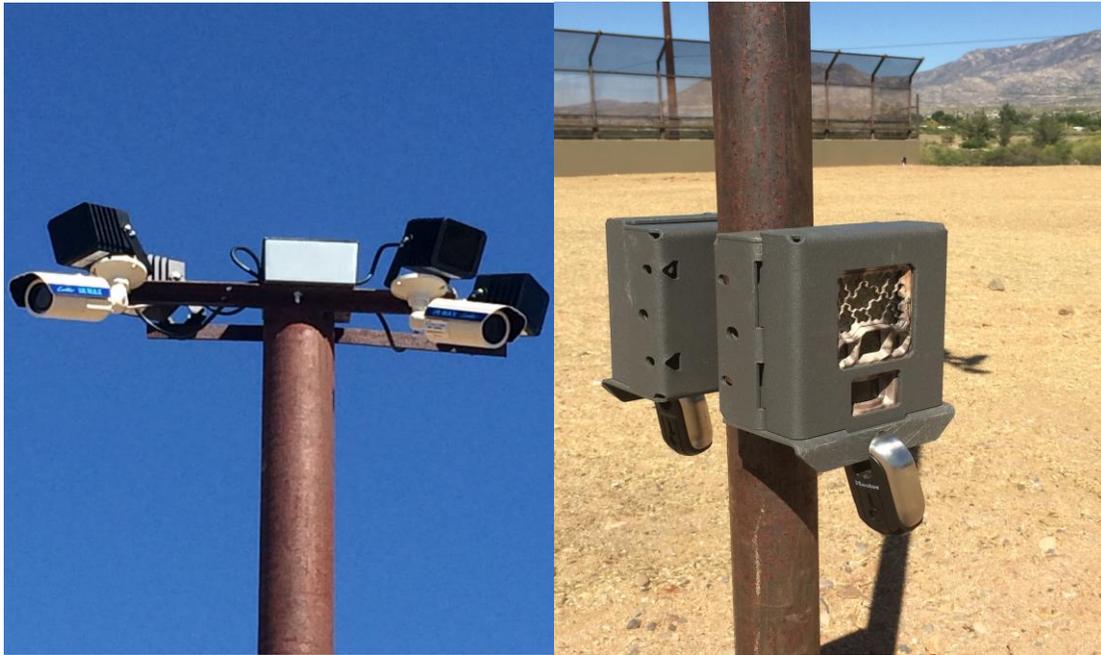
Figure 2. Structure surveillance system components: video camera with infra-red lights (left) with still camera (right) as backup documentation at the overpass and to capture wildlife use at the underpass.

we are using 8-camera video (overpass) and rapid-still frame cameras (e.g., Reconyx®, underpass). Video and still cameras provide detailed documentation of wildlife use and behavior in and near the newly constructed wildlife crossings along SR. We also installed backup Reconyx® cameras on the overpass to ensure no loss of data, in the event of short term video system failures. Long-term evaluation of the wildlife crossings is essential for a proper evaluation and future recommendations (Gagnon et al. 2011). All surveillance equipment was installed by AGFD and ADOT during the highway construction.

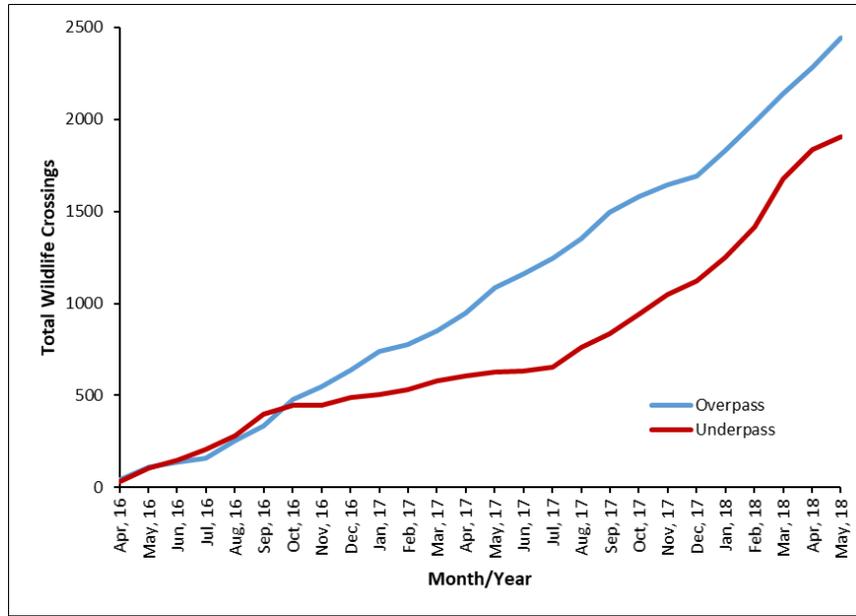
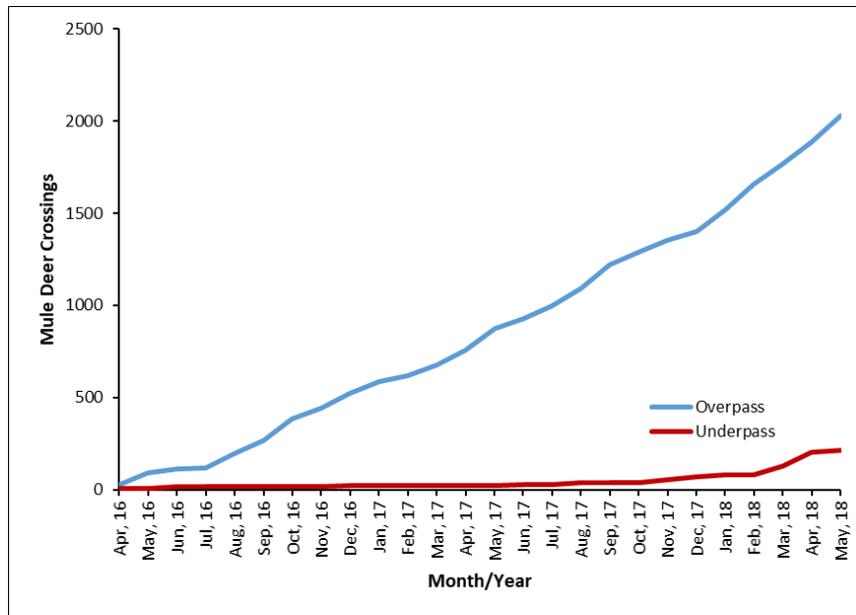
Figure 3. Total wildlife (top) and mule deer (bottom) use of the SR 77 overpass and underpass located on SR 77.

Observed crossing trends at the overpass can be seen to be relatively consistent for all wildlife, and for Mule Deer specifically since the 4th month of monitoring (Figure 3). Trends at the underpass have been more difficult to track given the disruption to monitoring caused by theft of the original trail cameras. However, crossings accumulated at a similar rate at the underpass prior to theft in October 2016 and after reinstallation of the original orientation in July 2017. Crossing accumulation rates at both structures exhibited an accelerating trend from December 2017 into early 2018.

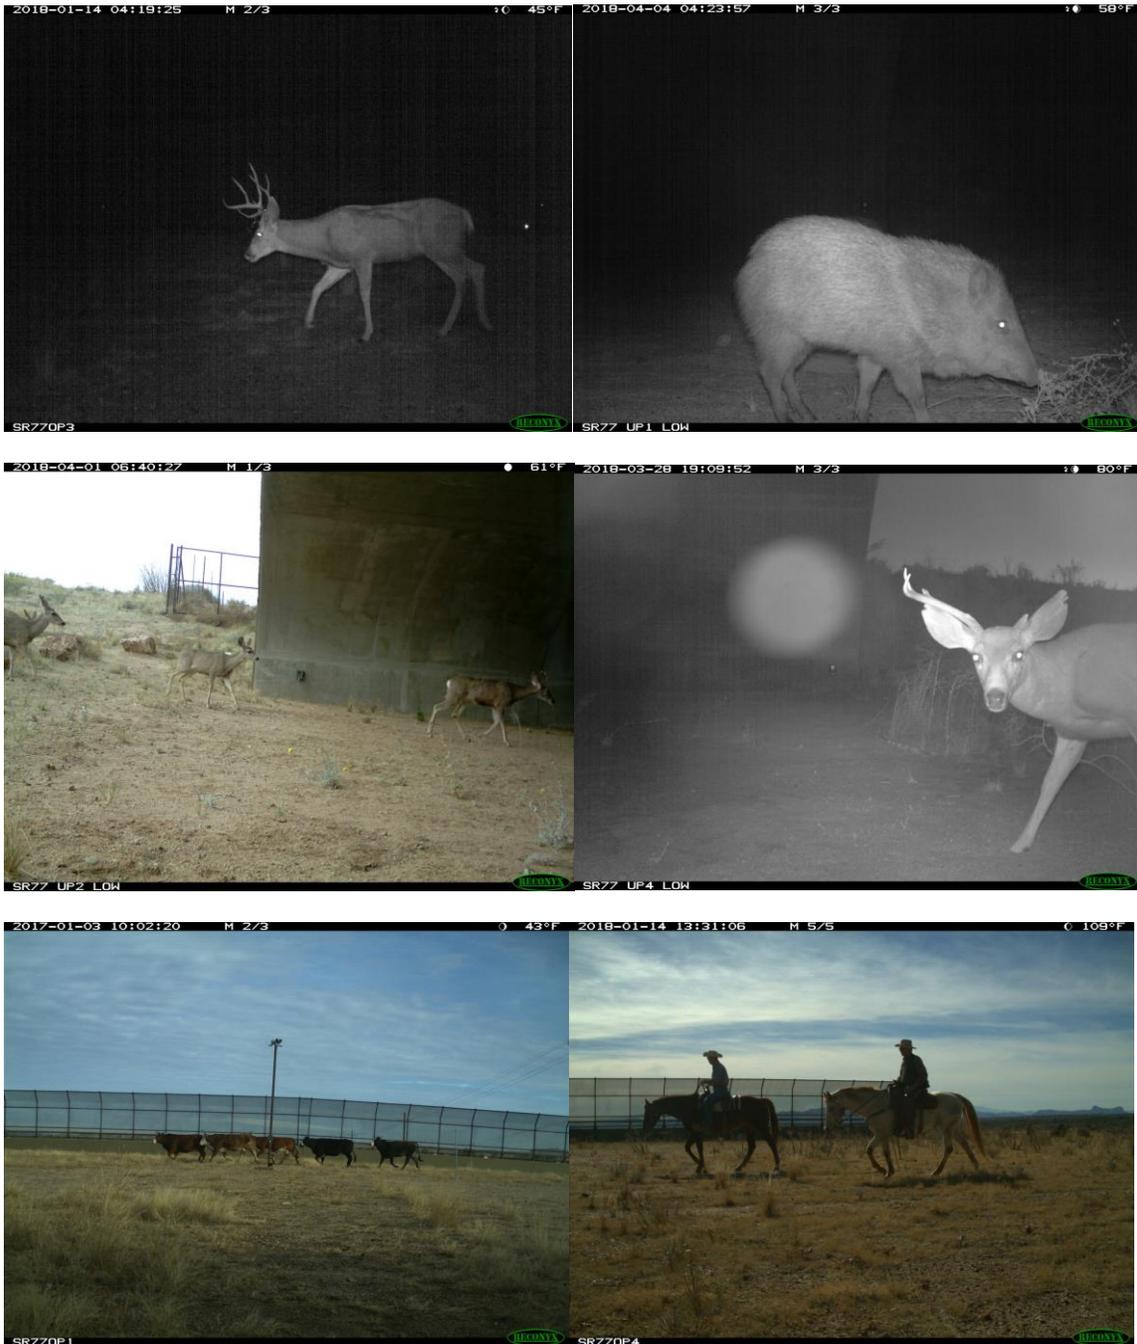
Figure 4. Examples of wildlife and non-wildlife events documented at the SR 77 overpass and underpass.

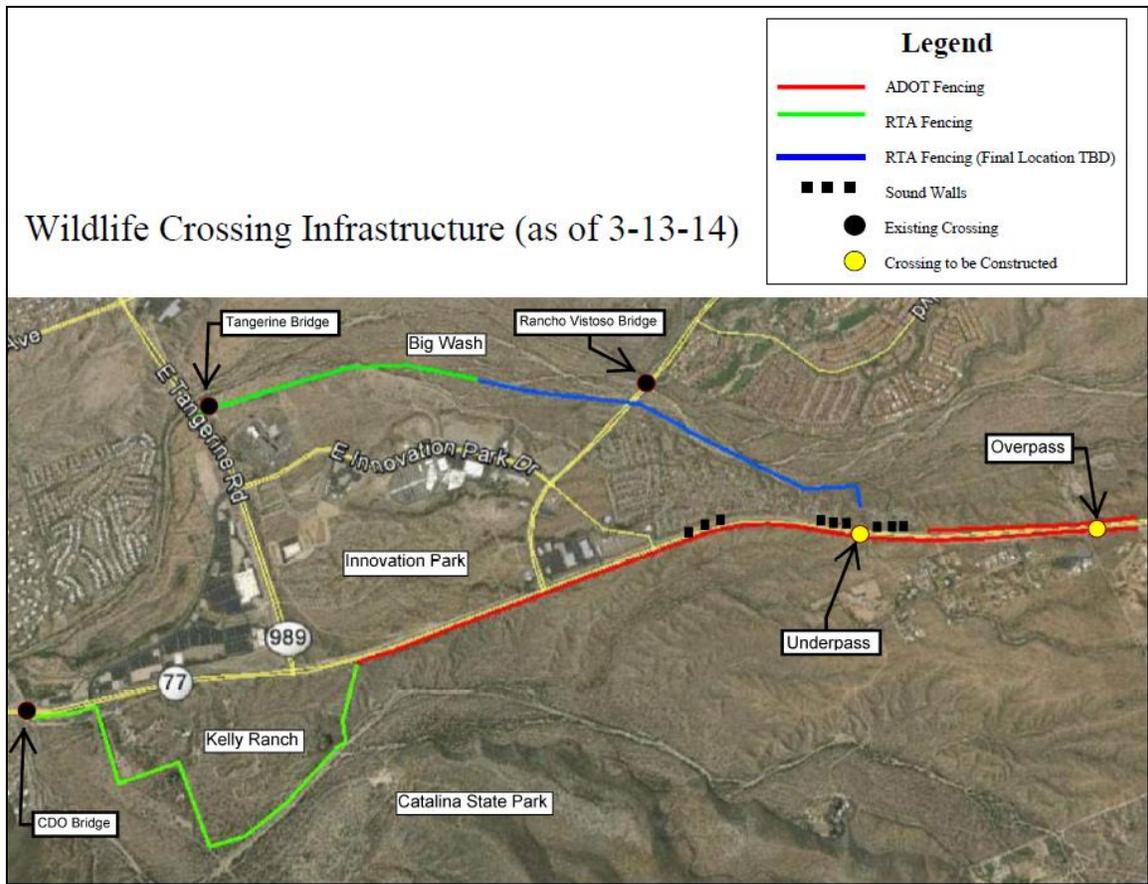
Figure 5. Map showing alignment of wildlife funnel-fencing and the complexities that will need to be accounted for (e.g. fencing distance from road) during road kill analysis. Map courtesy Coalition for Sonoran Desert Protection.

Funnel-fencing associated with most highway projects is generally placed along the right-of-way on each side of the road. Along the SR 77 project, designers have been forced to deviate

from this traditional alignment and take the fencing away from the road to avoid local communities/business (Figure 5). This orientation provides a unique opportunity to evaluate the effectiveness of fencing as it is pulled away from the road and encompasses additional habitat. These differences will be accounted for during road kill analysis and we will compare their relative effectiveness.

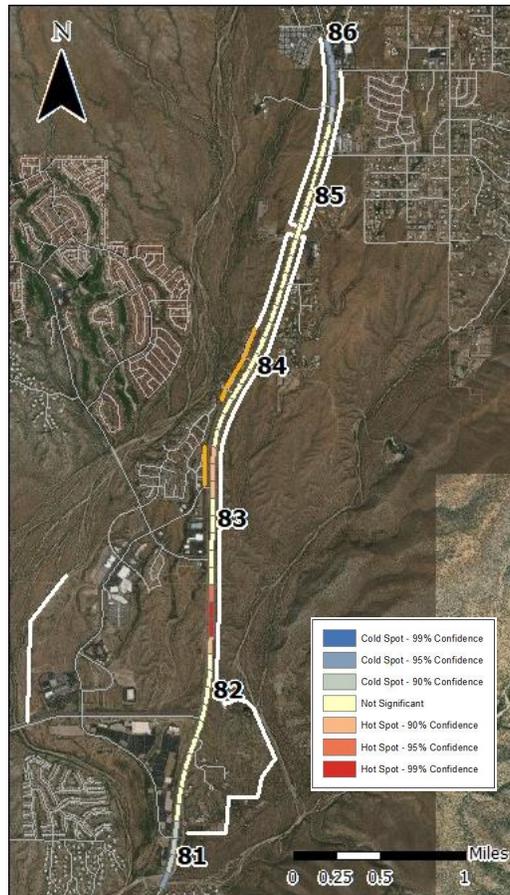
Figure 6. Optimized Hot Spot Analysis for all vertebrate mortalities through the Spring 2018 roadkill surveys with mileposts and installed wildlife fencing (white lines).

The status of installed wildlife fencing along the surveyed extent of SR77 allows us to compare the effectiveness of wildlife fencing in several configurations with respect to the ROW. There is evidence to suggest that installed wildlife fencing is proving effective throughout the surveyed extent. A single ungulate mortality has been recorded and very few carnivores were detected within the ROW. Where wildlife fence directly fronted the ROW on both sides mortality detections were found to be significantly lower than sections where fencing fronted only one or neither side (Figure 6). Mortality detections were significantly higher where wildlife fencing directly fronted one side of the ROW but was retracted or absent on the opposing side and lightly developed on that side. As installation of wildlife fencing is completed and

development within the fenced area occurs it is expected that currently observed hotspots will no longer be significant.

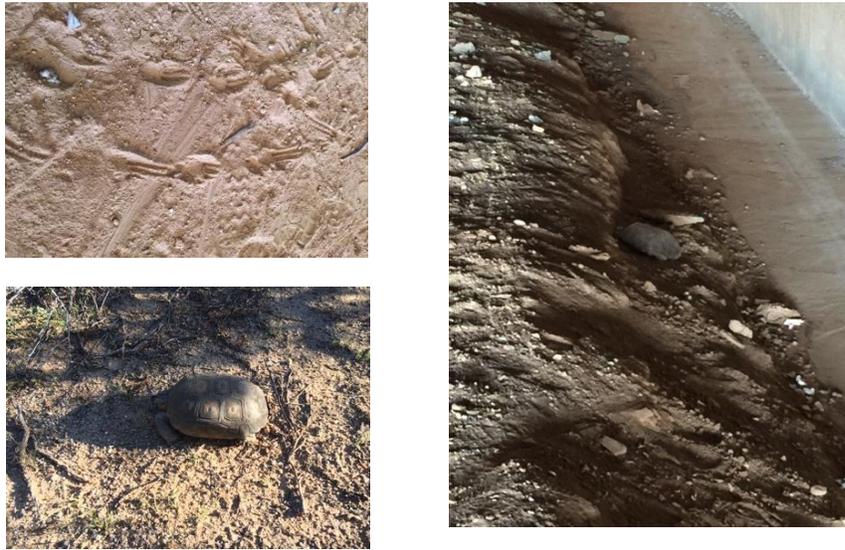
Figure 7. Sonoran desert tortoise found in the wildlife underpass during construction, tracks in underpass that alerted contractor (upper left), leading to location of tortoise in underpass (right) for safe removal from the site (lower left).

As with most wildlife species, roads are a nearly impermeable barrier to Sonoran Desert tortoises (SDT). Tortoises rarely cross roads due to their lack of mobility and they suffer high rates of mortality when they do attempt to cross. There is speculation that wildlife crossings can facilitate movement of desert tortoise across roads, however opportunities to evaluate the effectiveness of wildlife crossings for this species have been limited to date (Leavitt and Hoffman 2014). During the early stages of construction, project personnel removed several tortoises from the construction site, including one that attempted crossing through the underpass in October 2015 (Figure 7).

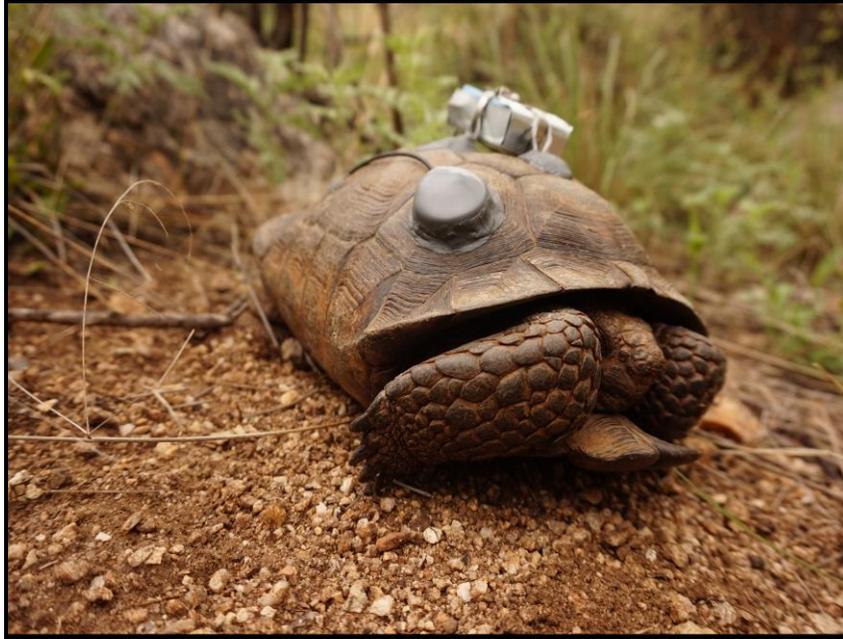
Figure 8. Sonoran Desert Tortoise with a VHF unit attached to front right and GPS unit attached on vertebral scutes.

To evaluate SDT movements along SR 77 we conducted visual surveys for the presence of SDTs and their sign adjacent to SR 77. These surveys were conducted on foot by qualified AGFD biologists where rights-of-entry have been granted. Upon detecting a live SDT, we fit the tortoises with a VHF radio-transmitter (Holohil RI-2B) and a GPS tracking unit. GPS tracking units are replaced monthly and data will be downloaded into ArcGIS so that we may estimate home range size, activity patterns, and movement corridors for each individual.

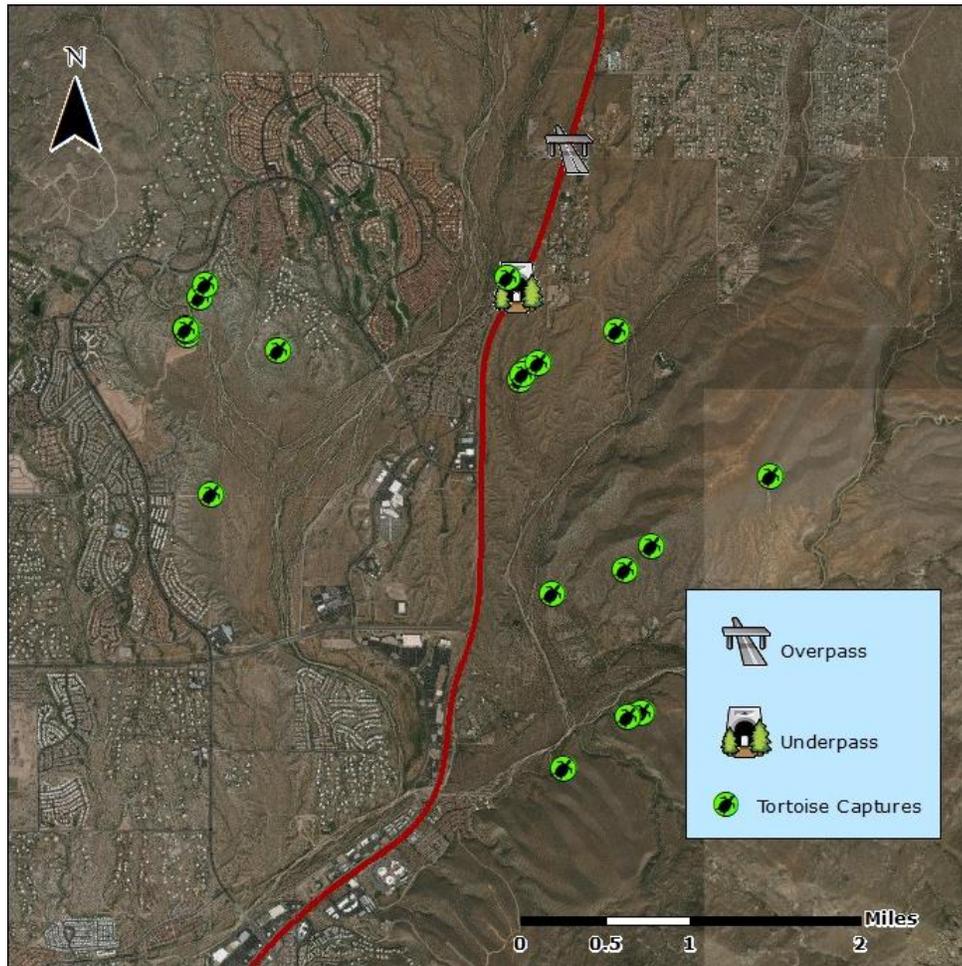
Figure 9. Distribution of Sonoran Desert Tortoise VHF and GPS transmitter deployments.

- **35 individuals detected of which 22 individuals have been outfitted with transmitters (12 east of 77, 10 west).**
- **4 outfitted individuals deceased (2 east and 2 west).**
- **17 individuals are currently outfitted with transmitters.**
- **GPS transmitters were redeployed for the 2018 season in April.**
- **Up to 2 additional transmitters will be deployed west of SR77 during the 2018 season.**
- **VHF transmitters will be replaced on most outfitted individuals during 2018.**
