Progress Report  
Monday, December 21, 2020

# Evaluation of Measures to Reduce Wildlife-Vehicle Collisions and Promote Connectivity in a Sonoran Desert Environment – State Route 77

*Santa Catalina – Tortolita Mountain Corridor*

Presented to the: Regional Transportation Authority

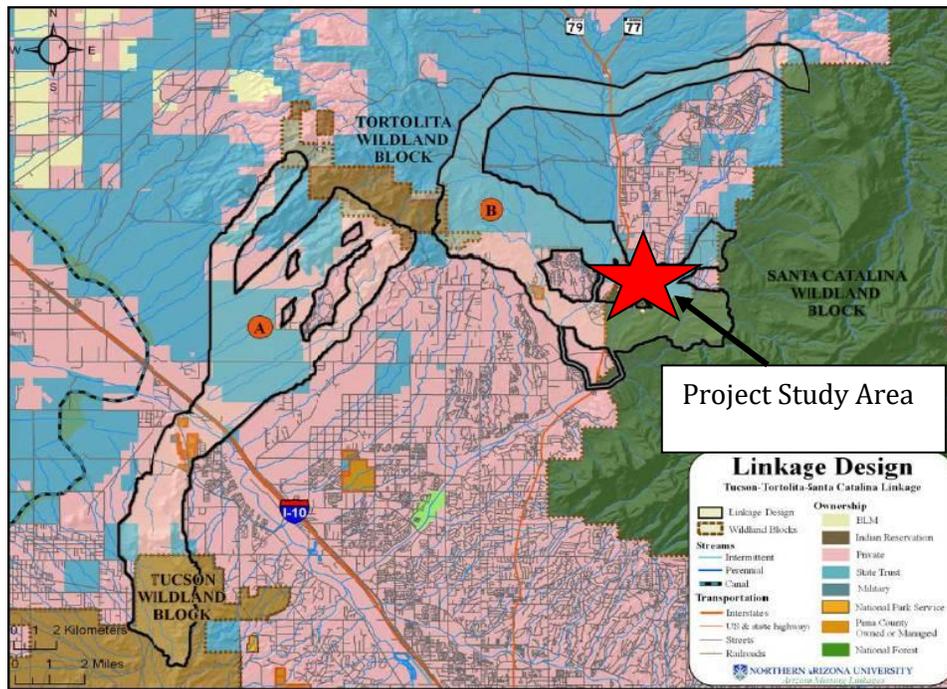
Figure 1. Least-cost linkage design for the Tucson, Tortolita, and Santa Catalina mountains and location of study area. Map from Beier et al. 2006.

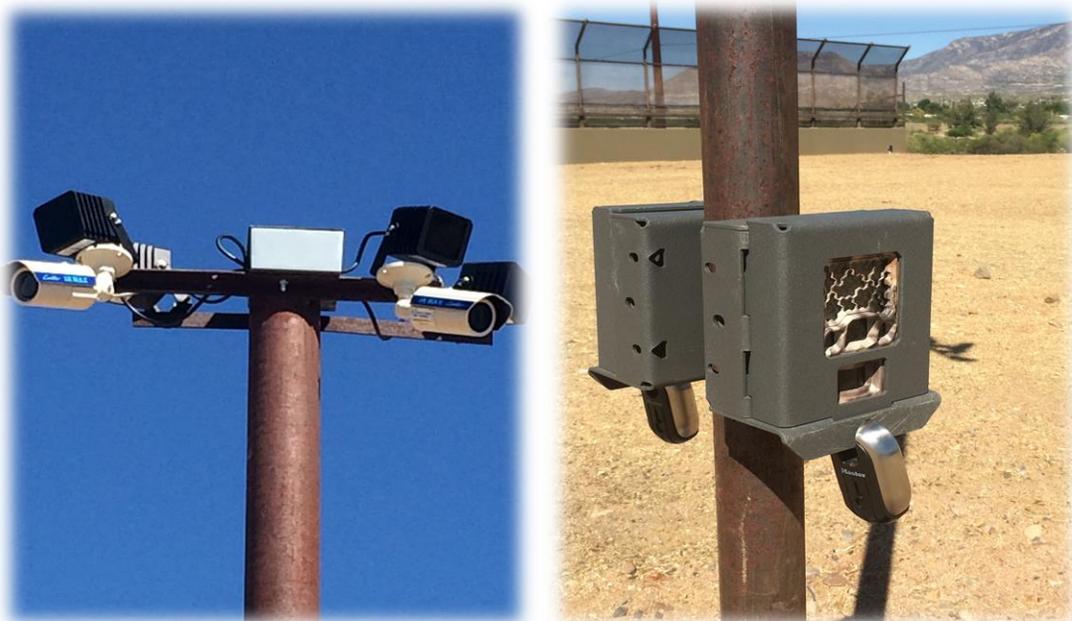
**Figure 2. Structure surveillance system components: video camera with infra-red lights (left) with still camera (right) as backup documentation at the overpass and to capture wildlife use at the underpass.**

Given the tremendous commitment by ADOT and RTA to provide wildlife crossing structures to reduce motorist collisions with wildlife and mitigate the impact of highway barrier effects, it is essential to evaluate their level of acceptance by Sonoran Desert wildlife. This is the primary objective of the post-construction monitoring study. To accomplish this objective, we are using 8-camera video (overpass) and rapid-still frame cameras (e.g., Reconyx®, underpass). Video and still cameras provide detailed documentation of wildlife use and behavior in and near the newly constructed wildlife crossings along SR. We also installed backup Reconyx® cameras on the overpass to ensure no loss of data, in the event of short-term video system failures. Long-term evaluation of the wildlife crossings is essential for a proper evaluation and future recommendations (Gagnon et al. 2011). All surveillance equipment was installed by AGFD and ADOT during the highway construction.

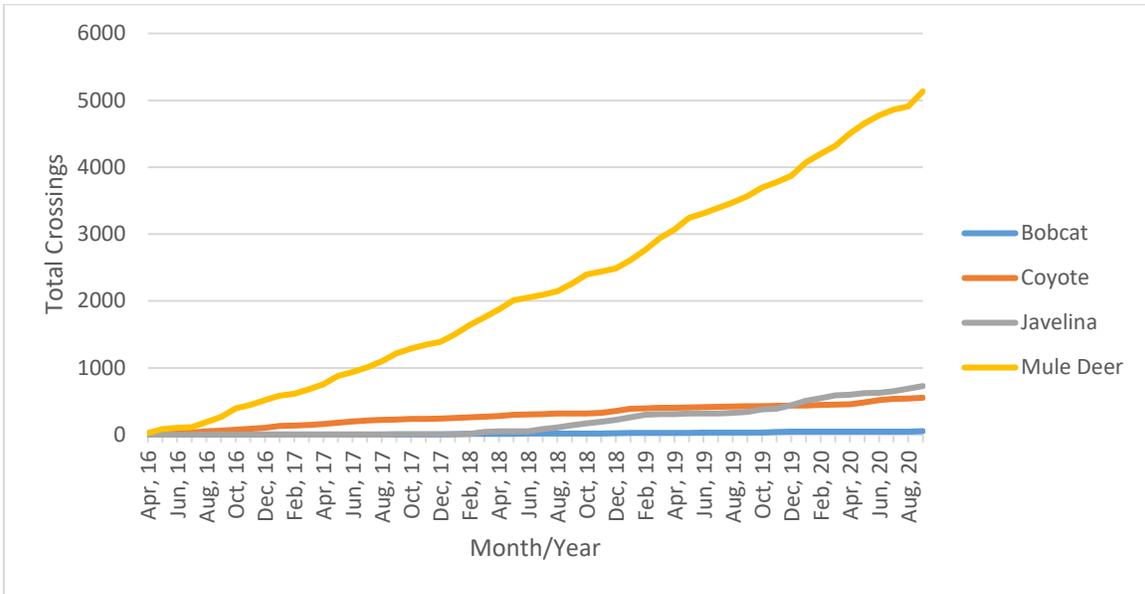
**Figure 3. Wildlife use of the overpass located on SR77 to September 30, 2020.**

Observed crossing accumulation trends at the overpass show that mule deer crossing rates have been increasing over the past 2 years, suggesting utilization by mule deer has not yet peaked (Figure 3). Javelina crossings have continued to be documented at an increased rate since July 2018 and are now more regularly observed than coyotes. Bobcat use continues to be documented at a low rate.

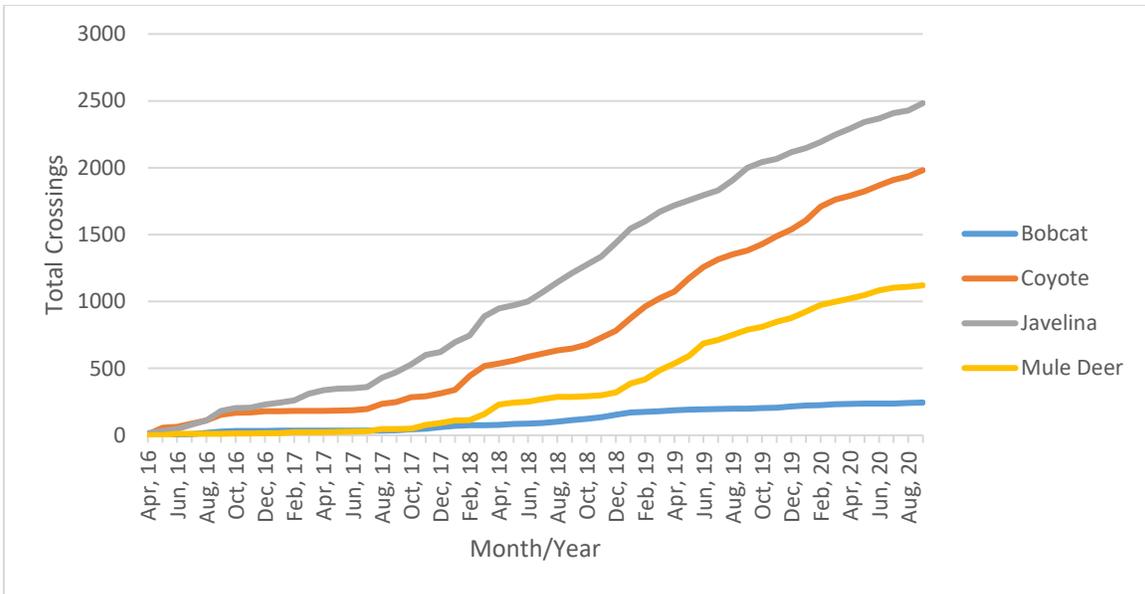
**Figure 4. Wildlife use of the underpass located on SR 77 to September 30, 2020.**

**As has been noted previously, trends at the underpass have been more difficult to track given the disruption to monitoring during 2016 and 2017. However, crossings accumulated at a similar rate at the underpass prior to theft in October 2016 and after reinstallation of the original orientation in July 2017 (Figure 4). Mule deer crossing rates have slowed over the last 12 months.**

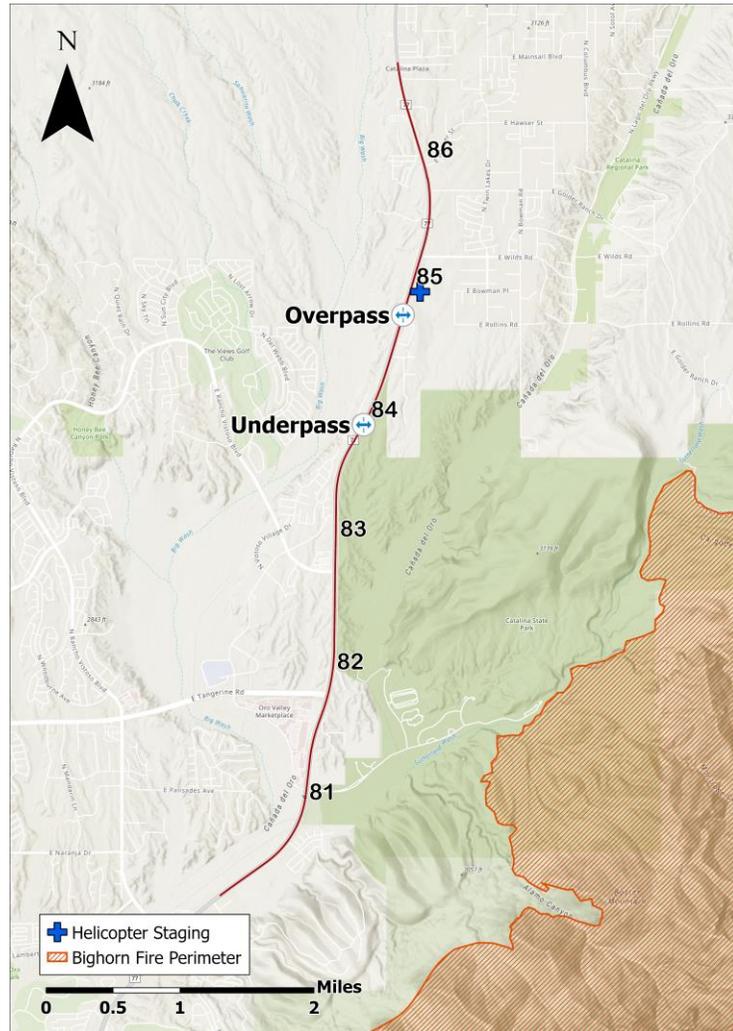
**Figure 5. Bighorn Fire perimeter and helicopter operations staging in relation to wildlife crossing locations.**

structures at its closest approach. Helicopter operations associated with the fire response were also staged within a quarter mile of the overpass, east of SR77 (Figure 5). A preliminary review of wildlife crossing trends for June, July, and August of 2020 when compared to the same period in 2017, 2018, and 2019 did not suggest a clear wildlife response to the Bighorn Fire at the crossing structures.

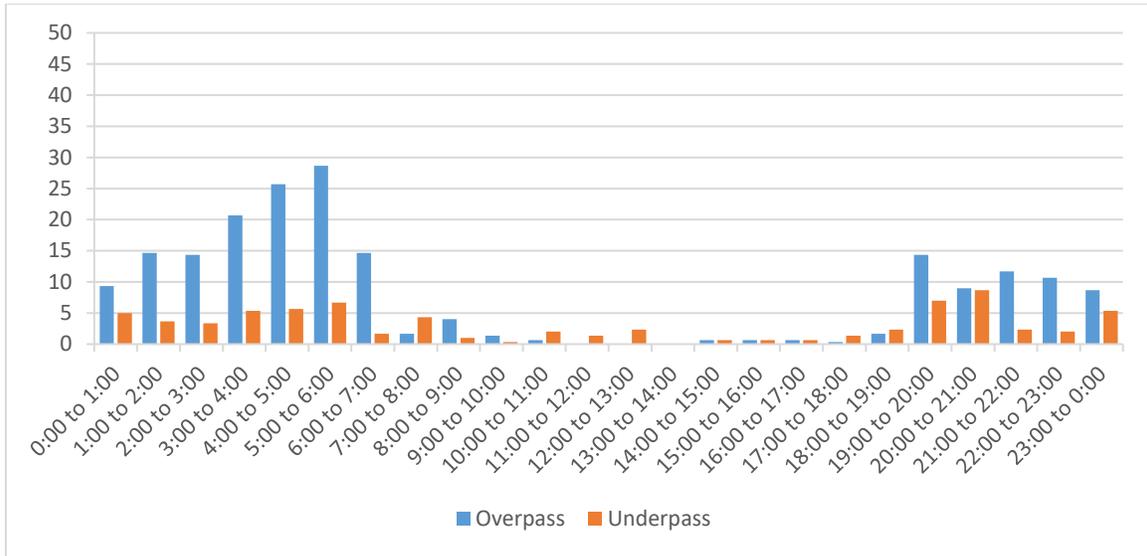
**Figure 6. Mean annual mule deer crossings by hour for the months of June, July, and August, years 2017, 2018, and 2019.**

Temporal patterns remained consistent with those observed in previous years for the most commonly detected species, as illustrated by mule deer crossing trends (Figures 6 & 7). During both periods mule deer primarily utilized both structures at night, with a clear peak at the overpass around dawn. Few crossings during daylight hours were recorded at either structure during either period.

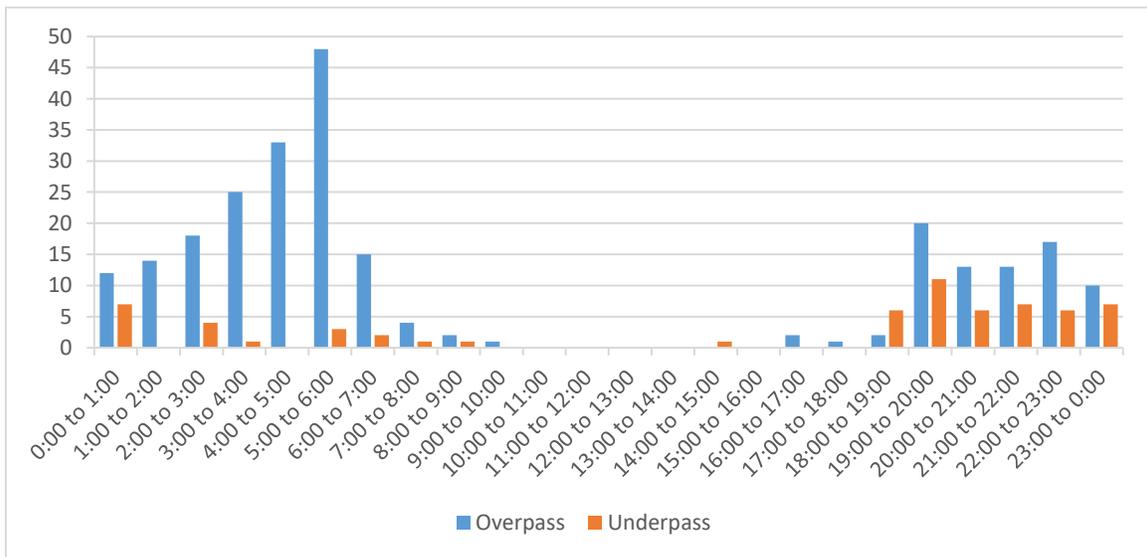
**Figure 7. Mule deer crossings by hour for the months of June, July, and August of 2020.**

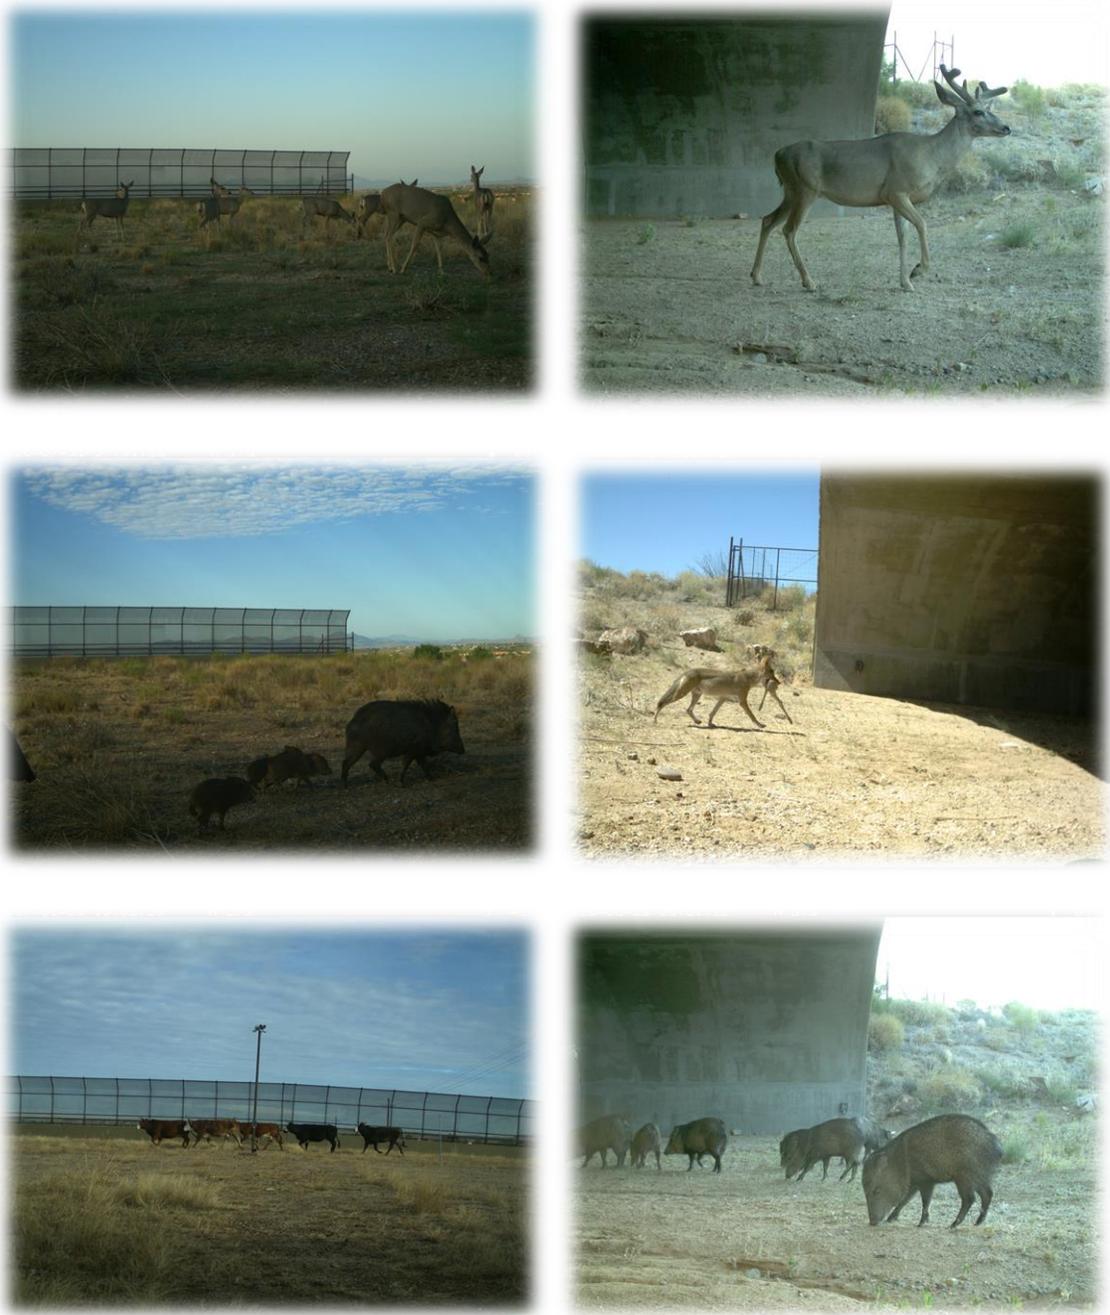
**Figure 8. Examples of wildlife and non-wildlife events documented at the SR 77 overpass and underpass.**

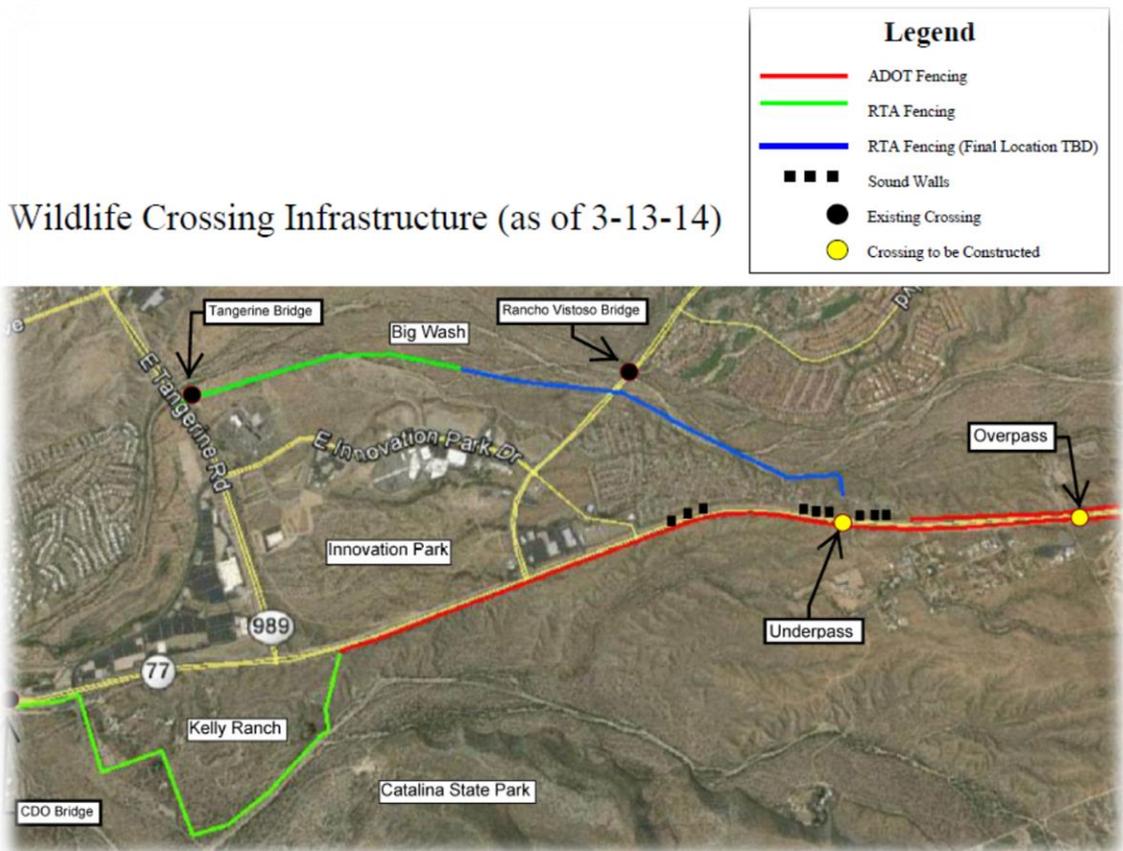
**Figure 9. Map showing alignment of wildlife funnel-fencing and the complexities that will need to be accounted for (e.g. fencing distance from road) during roadkill analysis. Map courtesy Coalition for Sonoran Desert Protection.**

Funnel-fencing associated with most highway projects is generally placed along the right-of-way on each side of the road. Along the SR 77 project, designers have been forced to deviate from this traditional alignment and take the fencing away from the road to avoid local communities/business (Figure 9). This orientation provides a unique opportunity to evaluate the effectiveness of fencing as it is pulled away from the road and encompasses additional habitat. These differences will be accounted for during roadkill analysis and we will compare their relative effectiveness.

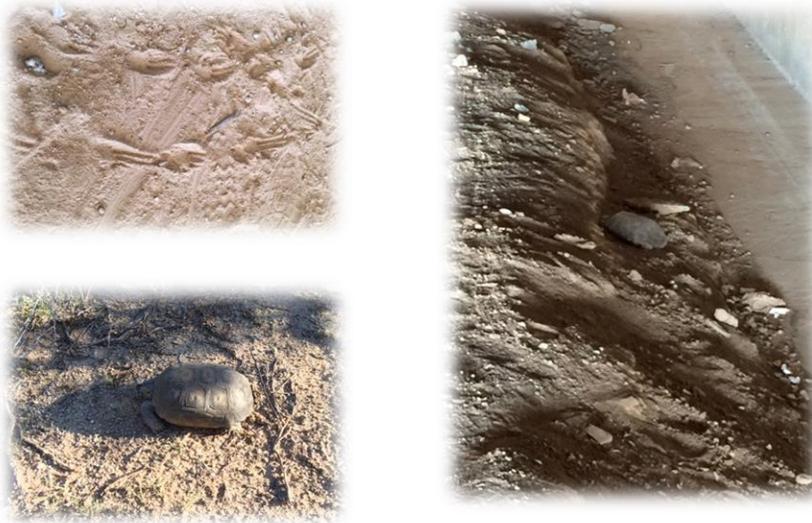
**Figure 10. Sonoran Desert tortoise found in the wildlife underpass during construction, tracks in underpass that alerted contractor (upper left), leading to location of tortoise in underpass (right) for safe removal from the site (lower left).**

As with most wildlife species, roads are a nearly impermeable barrier to Sonoran Desert tortoises (SDT). Tortoises rarely cross roads due to their lack of mobility and they suffer high rates of mortality when they do attempt to cross. There is speculation that wildlife crossings can facilitate movement of desert tortoise across roads, however opportunities to evaluate the effectiveness of wildlife crossings for this species have been limited to date (Leavitt and Hoffman 2014). During the early stages of construction, project personnel removed several tortoises from the construction site, including one that attempted crossing through the underpass in October 2015 (Figure 10).

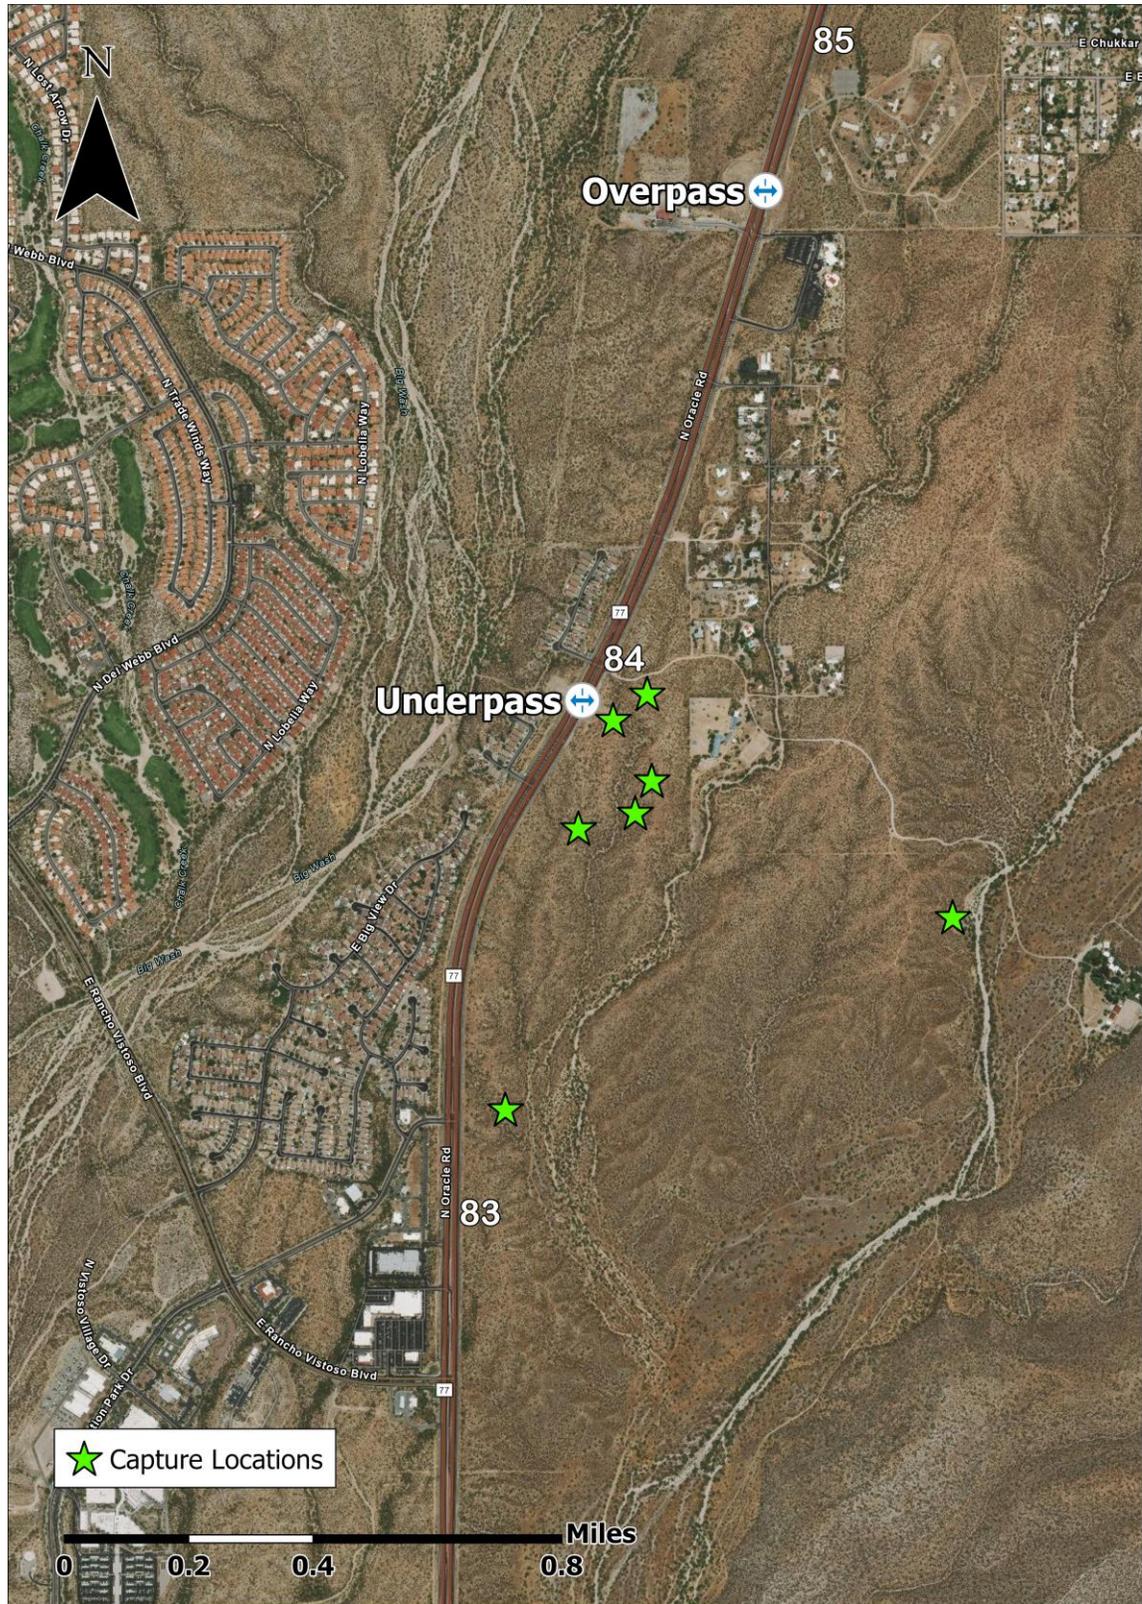
Figure 11. Location of new tortoise captures in 2020.

**Between June and September 2020 tortoise crews conducted 12 evening surveys around the wildlife crossing structures to locate and outfit additional tortoises with GPS transmitters. Surveys focused on suitable habitat within a half mile of SR77 between mileposts 83 and 86. Tortoise detection was hampered by an unusually dry monsoon, nonetheless, seven additional tortoises were located and outfitted with GPS units during 2020 (Figure 11). No new tortoises were located west of SR77, although recent scat was detected at two locations within a half mile of the underpass.**

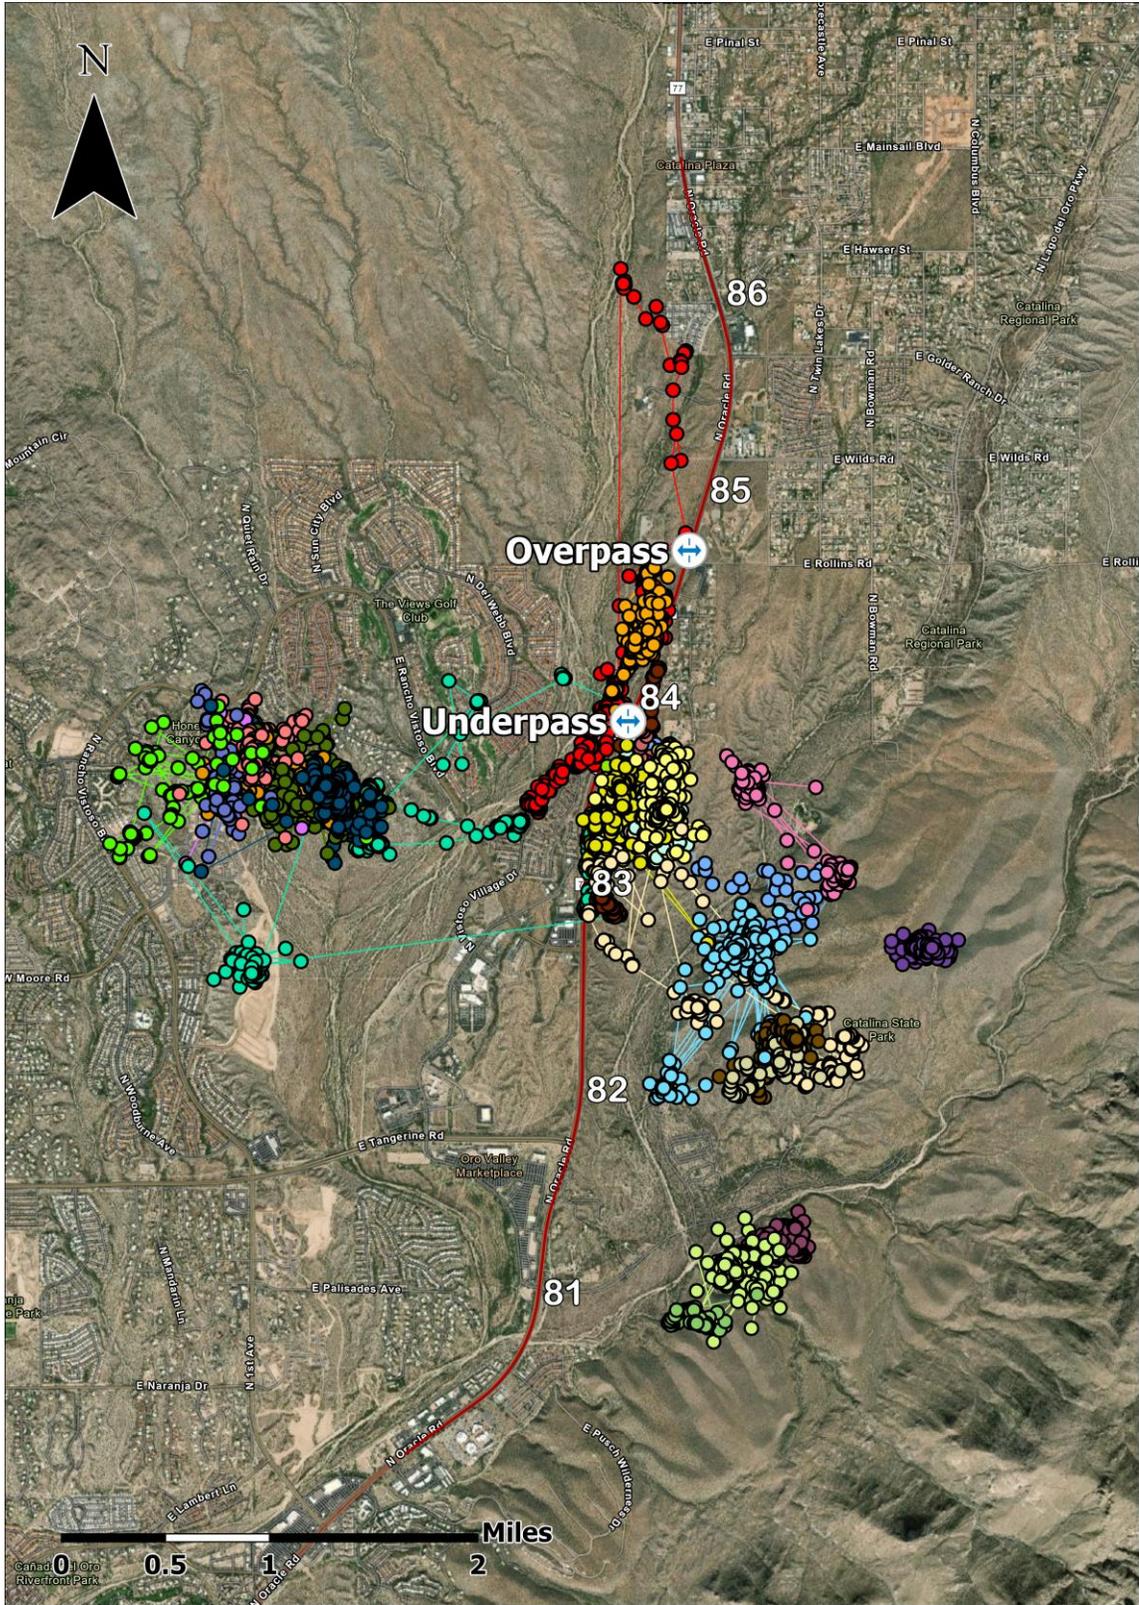
Figure 12. GPS locations from tracked tortoises from inception through the 2020 deployment season, each color represents a distinct individual.

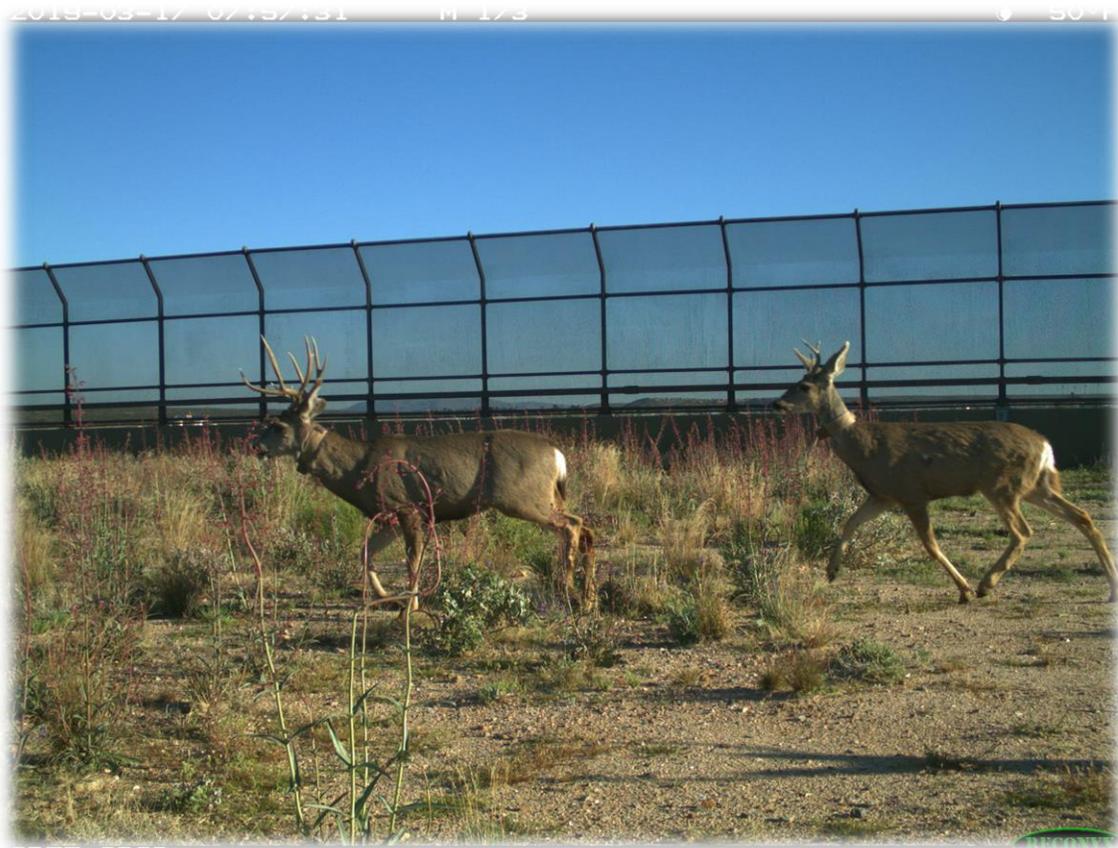
**Figure 11. Two collared mule deer bucks traversing the SR77 wildlife overpass.**

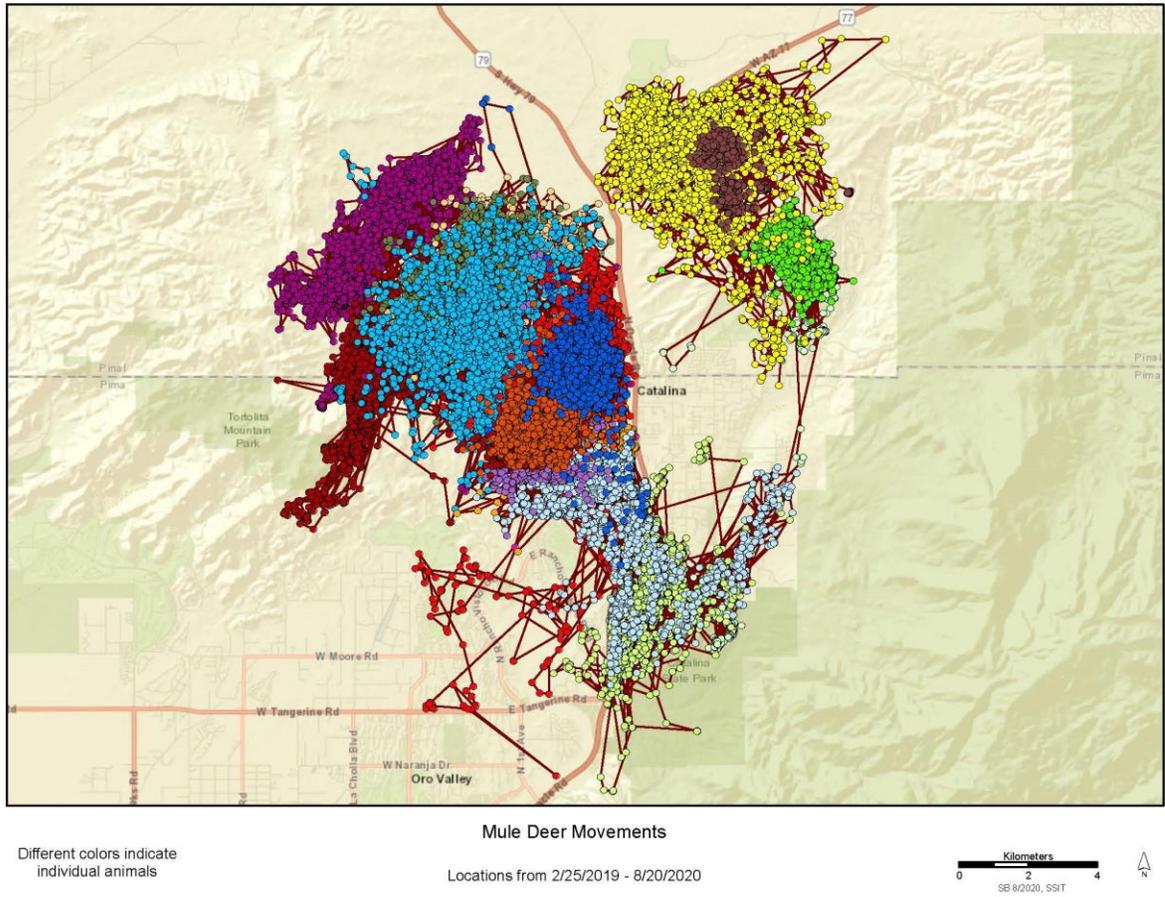
**Figure 12. GPS locations from collared mule deer from February 25, 2019 through September 14, 2020, each color represents a distinct individual.**

**Over 70,000 GPS locations from 20 mule deer have been recorded within the Catalina-Tortolita corridor between February 25, 2019 and September 14, 2020 (Figure 12). Regular crossings of SR77 within the redeveloped section have been documented by two individuals which were collared in proximity to the wildlife underpass. Crossing patterns are strongly associated with the two wildlife crossing structures. Seven mortalities of collared deer have been recorded, two being mountain lion kills, two of unknown cause, and three vehicle collisions. Vehicle collisions with collared deer occurred on SR77 at the northern terminus of the wildlife fence, on SR77 east of Oracle Junction, and on Rancho Vistoso Boulevard at the Big Wash bridge. We plan to redeploy recovered collars in 2021.**
