Progress Report
Thursday, December 30, 2021

Evaluation of Measures to Reduce Wildlife- Vehicle Collisions and Promote Connectivity in a Sonoran Desert Environment – State Route 77

Santa Catalina – Tortolita Mountain Corridor

Submitted by the:
Arizona Game and Fish Department
Wildlife Contracts Branch

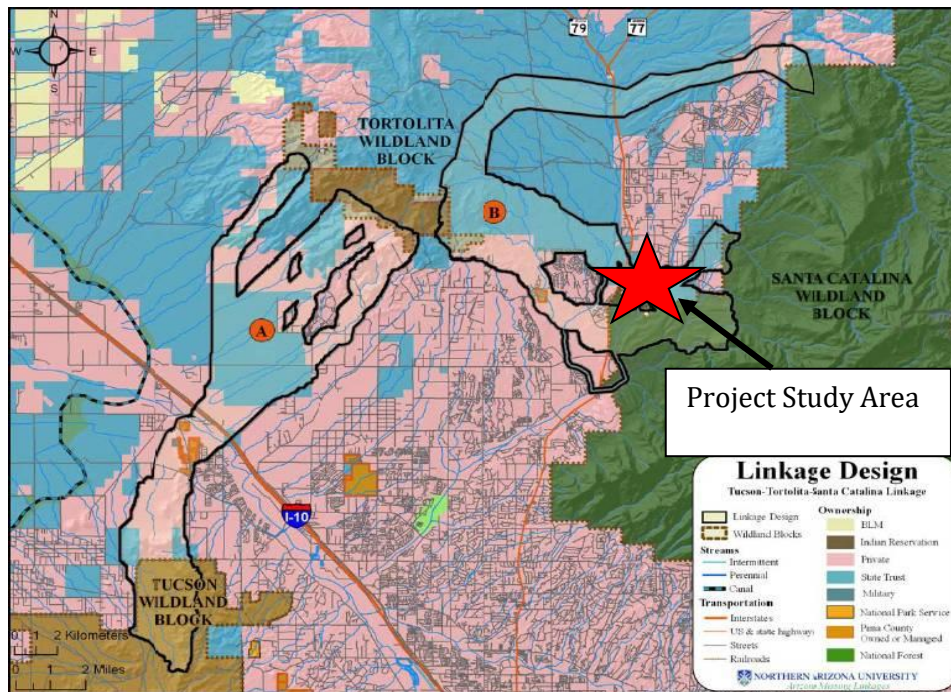
Figure 1. Least-cost linkage design for the Tucson, Tortolita, and Santa Catalina mountains and location of study area. Map from Beier et al. 2006.

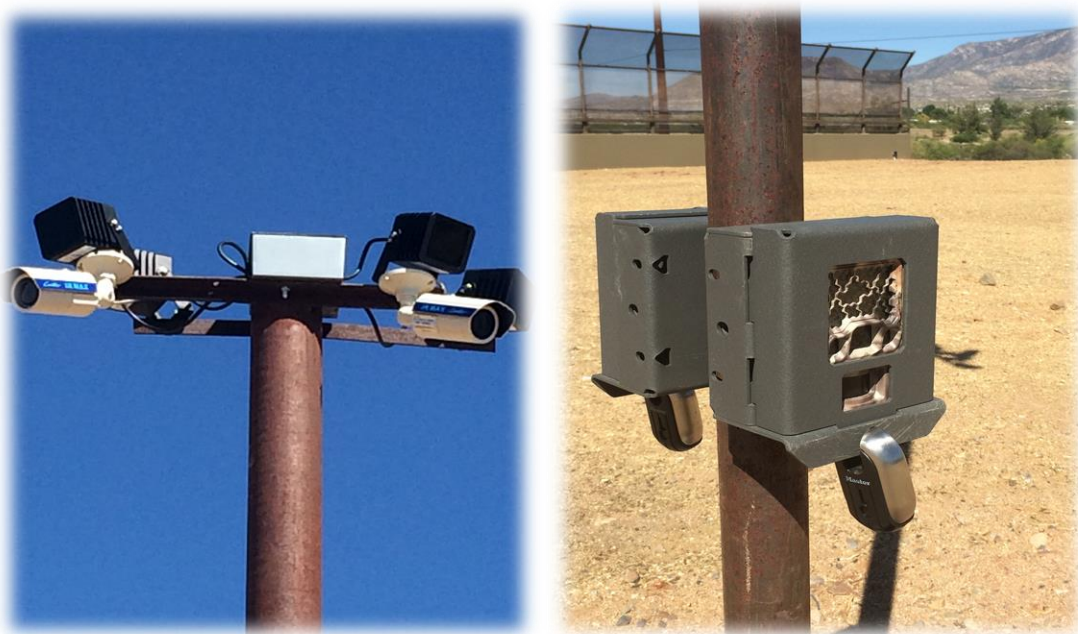
Figure 2. Structure surveillance system components: video camera with infra-red lights (left) with still camera (right) as backup documentation at the overpass and to capture wildlife use at the underpass

Given the tremendous commitment by ADOT and RTA to provide wildlife crossing structures to reduce motorist collisions with wildlife and mitigate the impact of highway barrier effects, it is essential to evaluate their level of acceptance by Sonoran Desert wildlife. This is the primary objective of the post-construction monitoring study. To accomplish this objective, we are using 8-camera video (overpass) and rapid-still frame cameras (e.g., Reconyx®, underpass). Video and still cameras provide detailed documentation of wildlife use and behavior in and near the newly constructed wildlife crossings along SR. We also installed backup Reconyx® cameras on the overpass to ensure no loss of data, in the event of short-term video system failures. Long-term evaluation of the wildlife crossings is essential for a proper evaluation and future recommendations (Gagnon et al. 2011). All surveillance equipment was installed by AGFD and ADOT during the highway construction.

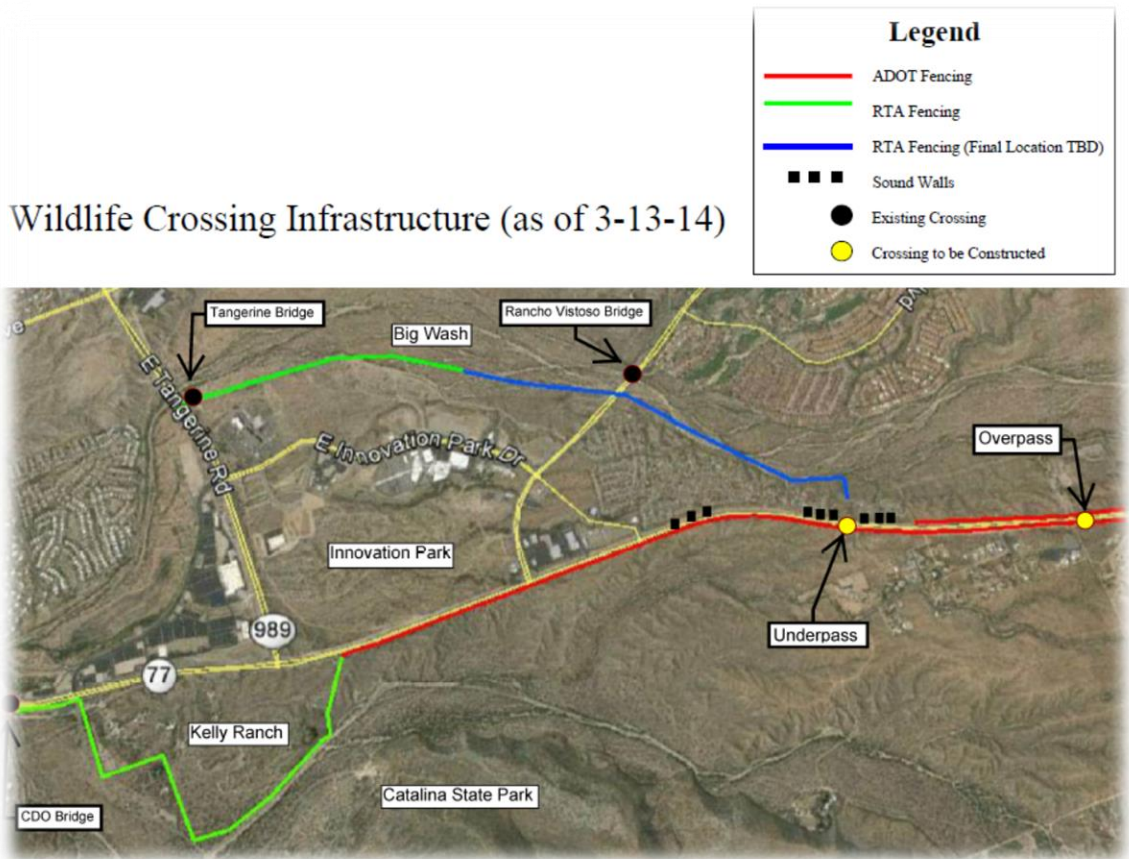
Figure 3. Map showing alignment of wildlife funnel-fencing and the complexities that will need to be accounted for (e.g., fencing distance from road) during roadkill analysis. Map courtesy Coalition for Sonoran Desert Protection

Funnel-fencing associated with most highway projects is generally placed along the right-of-way on each side of the road. Along the SR 77 project, designers have been forced to deviate from this traditional alignment and take the fencing away from the road to avoid local communities/business (Figure 3). This orientation provides a unique opportunity to evaluate the effectiveness of fencing as it is pulled away from the road and encompasses additional habitat. These differences will be accounted for during roadkill analysis and we will compare their relative effectiveness.

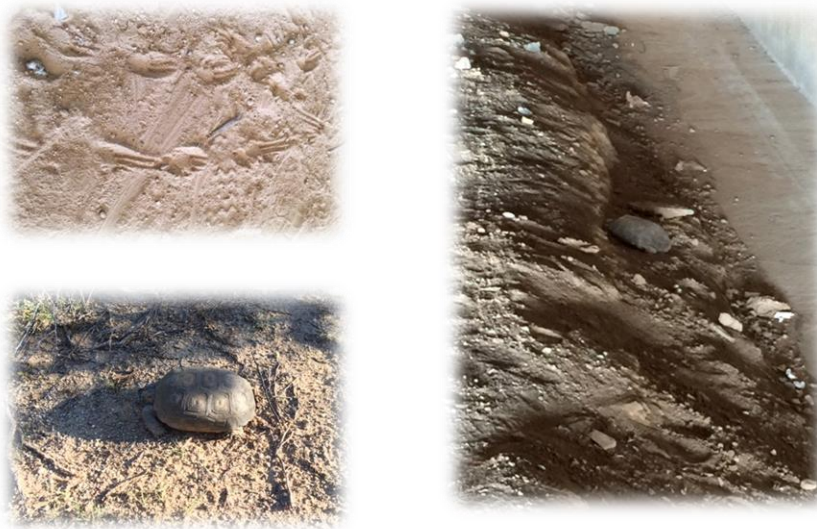
Figure 4. Sonoran Desert tortoise found in the wildlife underpass during construction, tracks in underpass that alerted contractor (upper left), leading to location of tortoise in underpass (right) for safe removal from the site (lower left)

As with most wildlife species, roads are a nearly impermeable barrier to Sonoran Desert tortoises (SDT). Tortoises rarely cross roads due to their lack of mobility and they suffer high rates of mortality when they do attempt to cross. There is speculation that wildlife crossings can facilitate movement of desert tortoise across roads, however opportunities to evaluate the effectiveness of wildlife crossings for this species have been limited to date (Leavitt and Hoffman 2014). During the early stages of construction, project personnel removed several tortoises from the construction site, including one that attempted crossing through the underpass in October 2015 (Figure 4).

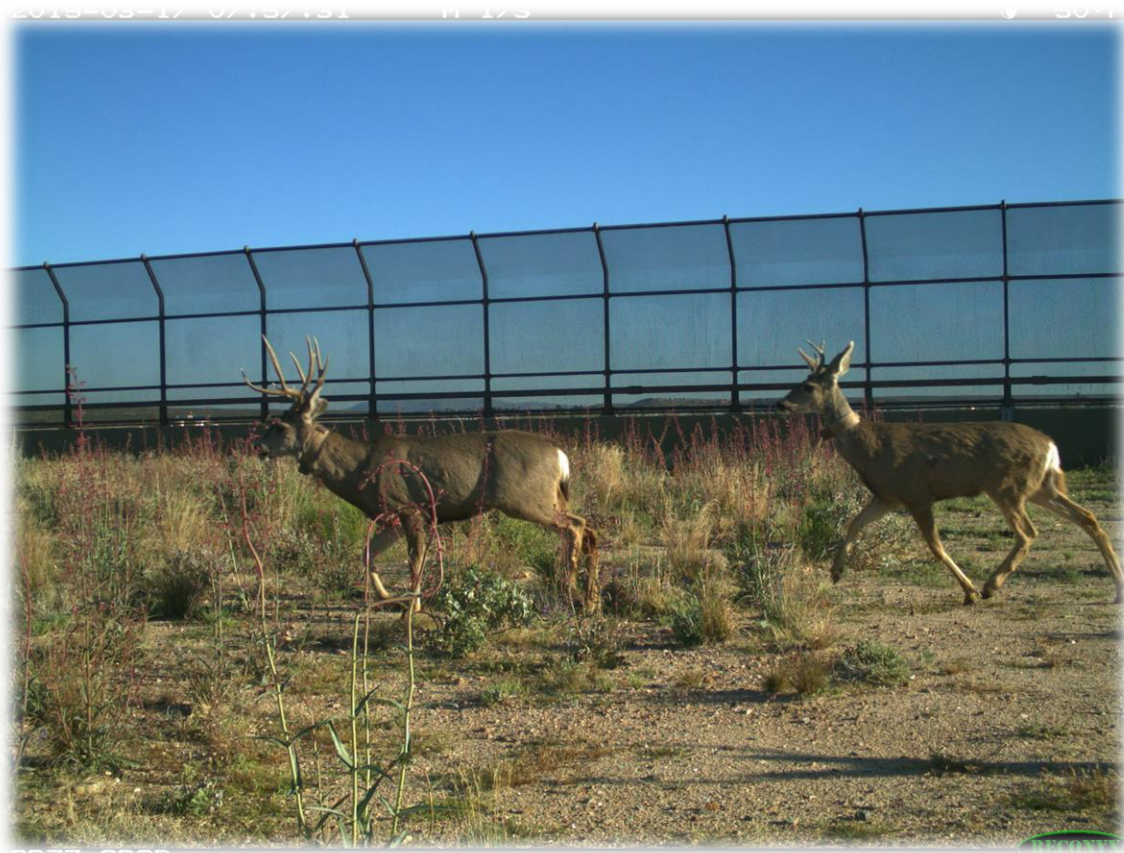
Figure 5. Two collared mule deer bucks traversing the SR77 wildlife overpass

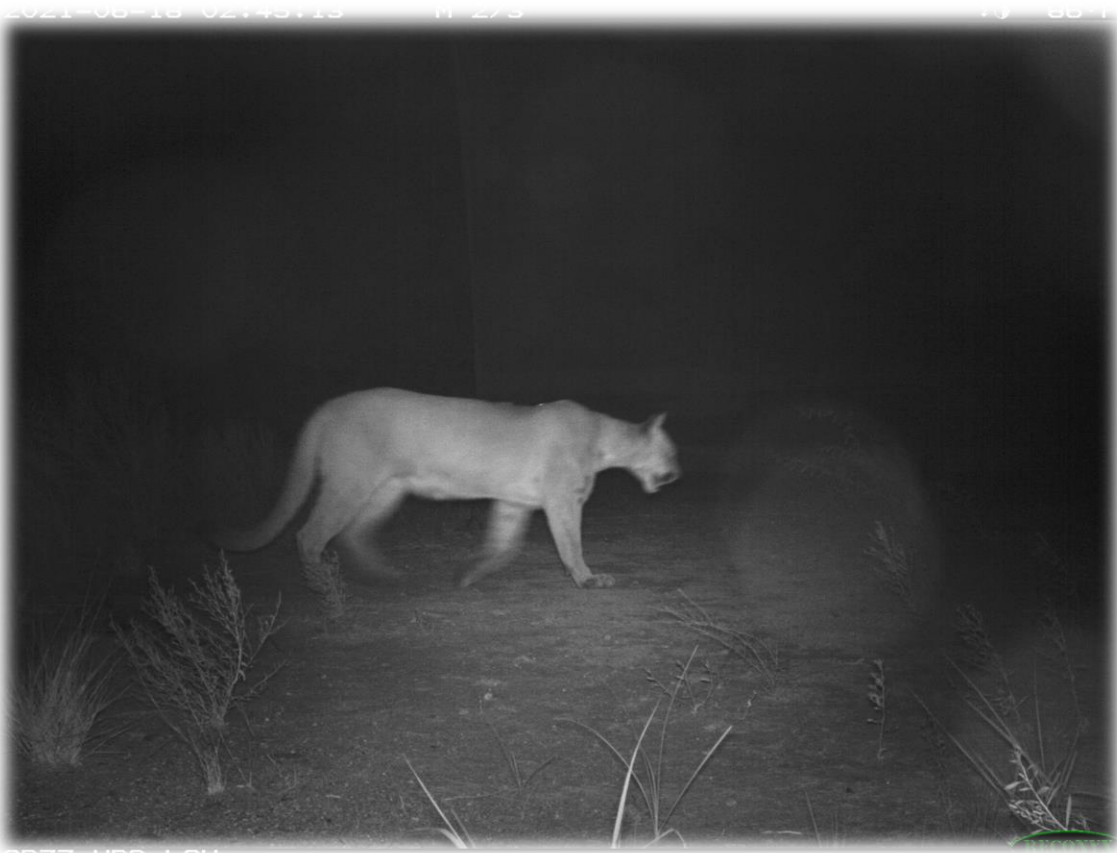
Figure 6. Mountain lion crossing SR77 wildlife underpass

A total of 31 native vertebrate species have been documented at the crossing structures, 14 at the overpass, and 30 at the underpass. Of these, 23 have been documented crossing SR77, 13 at the overpass, and 22 at the underpass (Table 1). Since the last update, a mountain lion was documented crossing the underpass in June of 2021, the first confirmed mountain lion crossing at either structure (Figure 6).

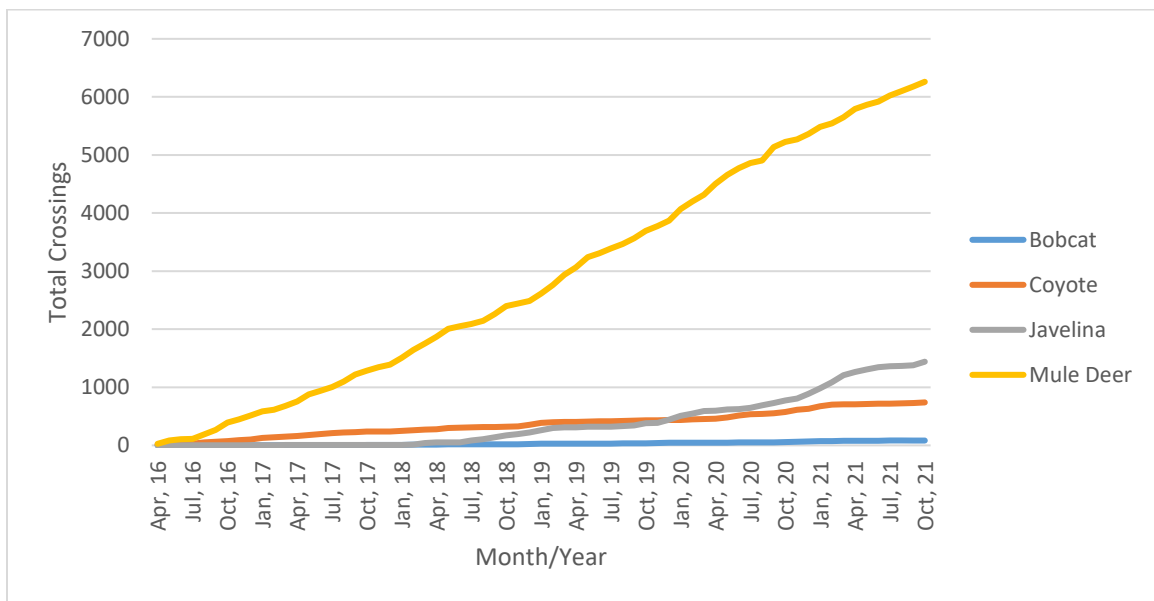
Figure 7. Wildlife use of the overpass located on SR77 to October 31, 2021.

Observed crossing accumulation trends at the overpass show that mule deer and coyote crossings continue to accumulate relatively steadily (Figure 7). Crossing rates for javelina appear to show seasonal pulses from the monsoon through winter with reduced crossings during spring and early summer. Bobcat use continues to be documented at a low rate.

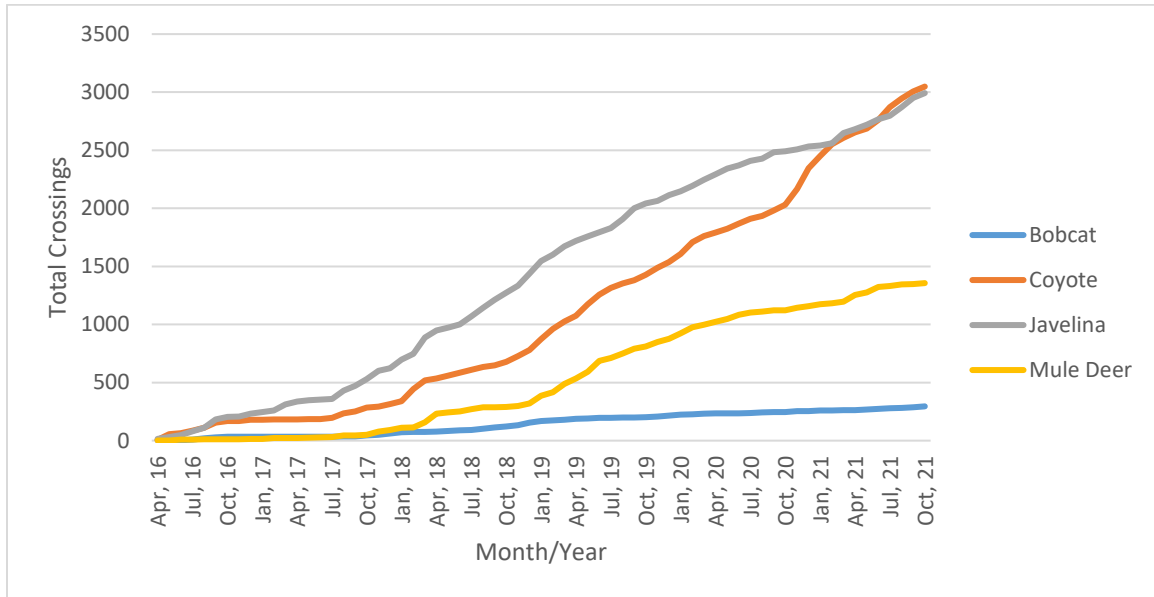
Figure 8. Wildlife use of the underpass located on SR 77 to April 30, 2021

As has been noted previously, early trends at the underpass were more difficult to track given the disruption to monitoring during 2016 and 2017. However, crossing patterns over time are becoming clearer given the lack of disruption since July 2017. Crossing accumulation rates for javelina have increased since January 2021 while mule deer crossing rates show no clear pattern. Coyote crossings have continued to accumulate at a high rate and coyote use of the underpass has now outstripped use by javelina over the course of the project. Crossing accumulation rates for bobcat remain low but consistent.

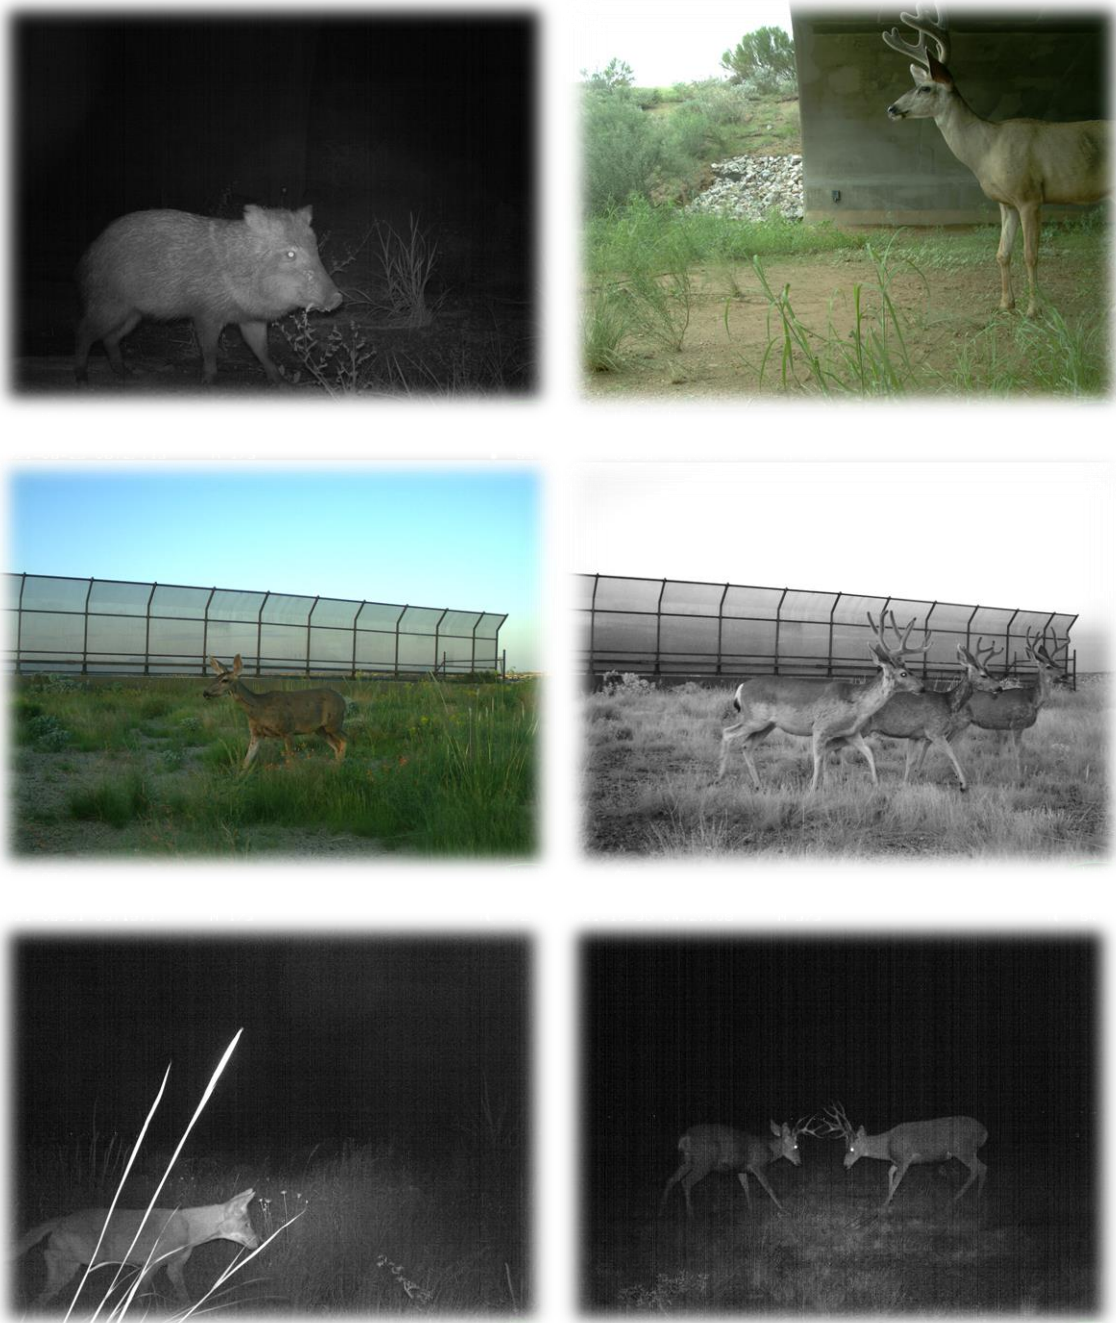
Figure 9. Examples of wildlife events documented at the SR 77 overpass and underpass

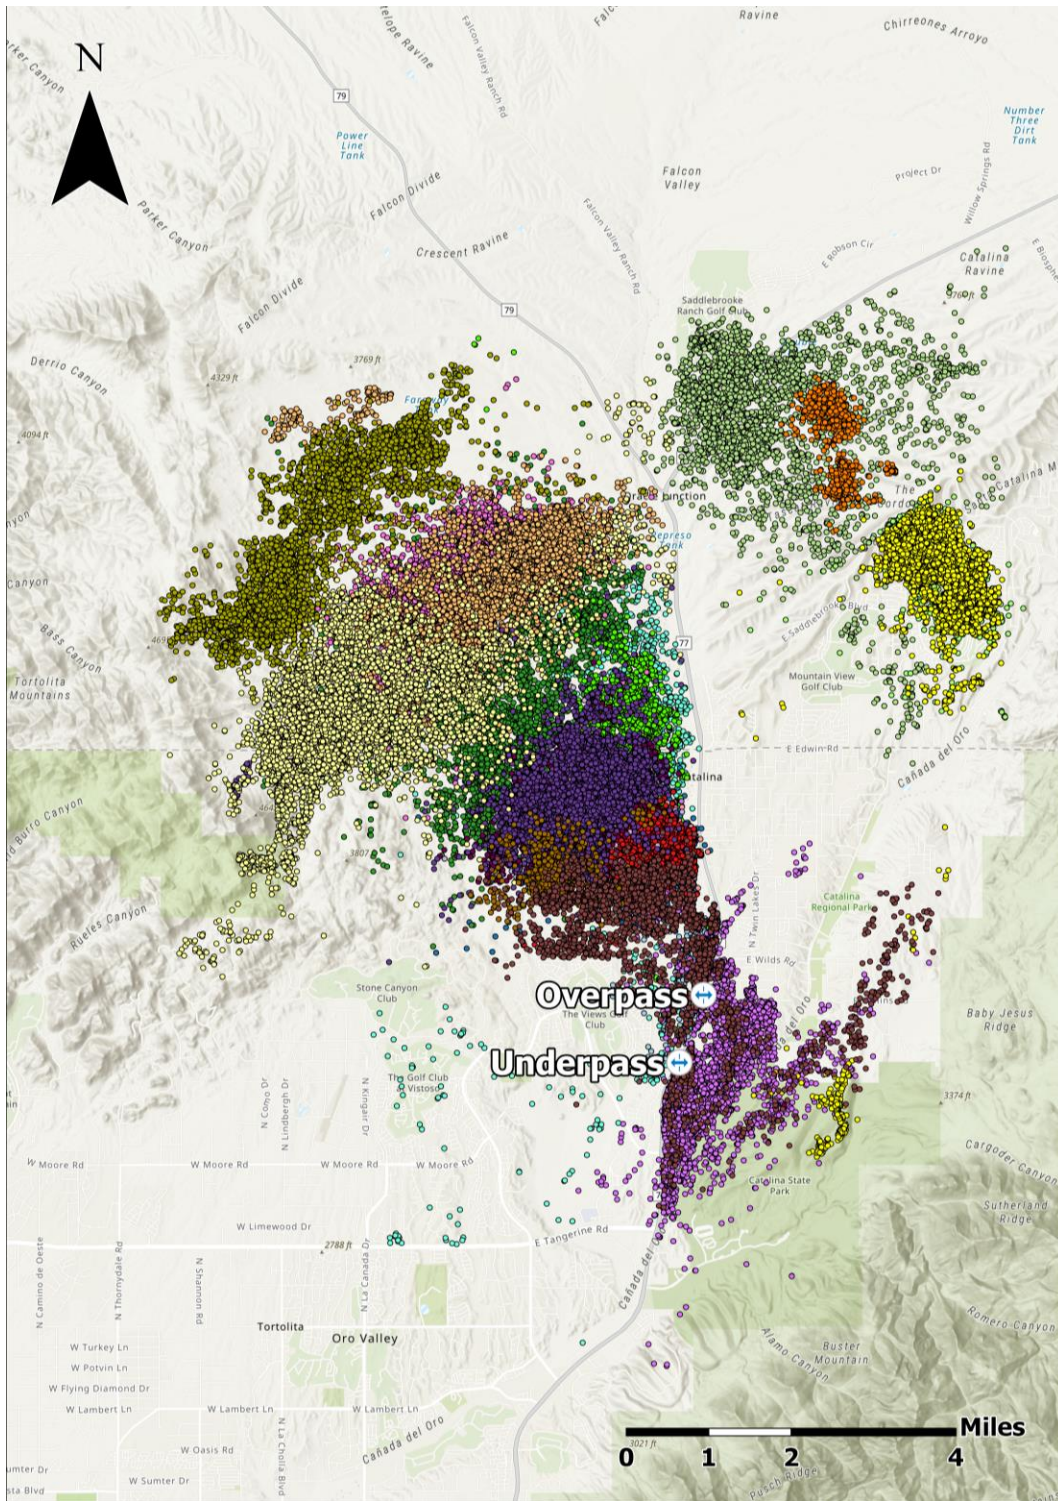
Figure 10. GPS locations from collared mule deer from February 25, 2019, through December 20, 2021, each color represents a distinct individual.

Over 210,000 GPS locations from 22 mule deer have been recorded within the Catalina-Tortolita corridor (Figure 10). Regular crossings of SR77 within the redeveloped section continue to be documented. Crossing patterns are strongly associated with the two wildlife crossing structures. No further mortalities of collared deer have occurred since the previous update, twelve mule deer are currently outfitted with active collars.
