Progress Report
Thursday, December 30, 2021

Habitat Establishment Evaluation of Tangerine Road Phase I: Road Mortality and Crossing Structure Utilization

Presented to the: Regional Transportation Authority

Submitted by the:
Arizona Game and Fish Department
Wildlife Contracts Branch

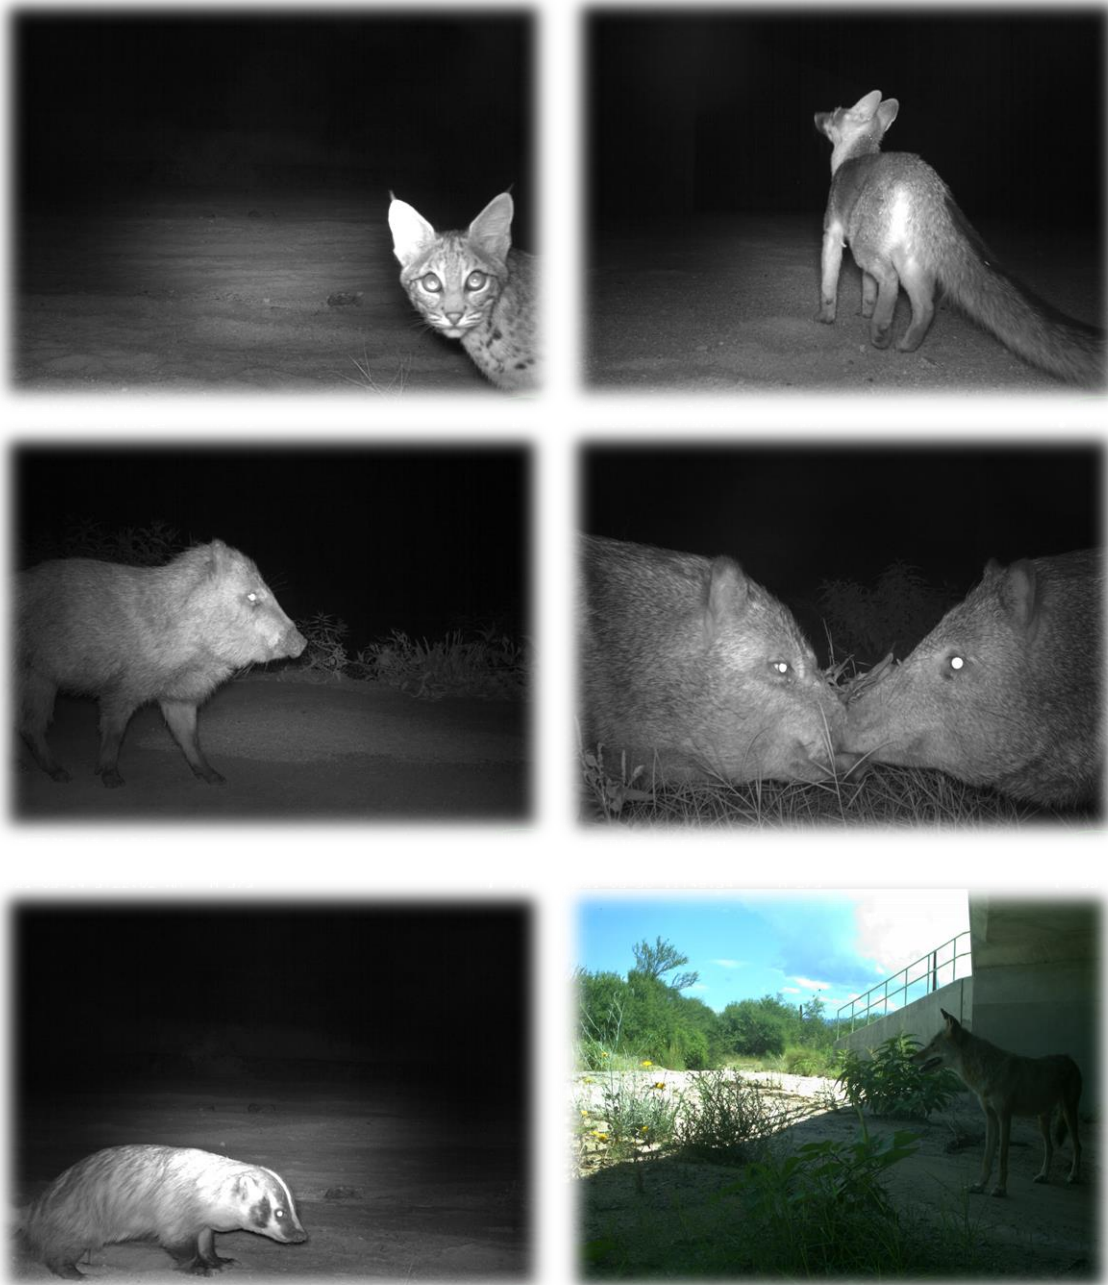
Figure 11. Examples of wildlife events documented at the Tangerine Rd wildlife underpasses

Crossing data has been analyzed to November 29th, 2021. A combined total of 11422 crossings by 28 wildlife species have been recorded across all five structures. Coyote, javelina, mule deer, gambel's quail, and bobcat constitute the most commonly documented species with 5473, 2992, 933, 895, and 692 crossings respectively, representing 96% of all documented crossings. Crossings of note include a gila monster at UP-4 in April 2019, and a mountain lion at UP-2 in June 2019. Figure 11 shows a selection of the images collected so far.
