SAFE PASSAGES FOR WILDLIFE ON I-10 EAST FINAL REPORT

Project No.	U19008	Reporting period:	6/26//2019 – 6/26/2022
Project Title:	Safe Passages for Wildlife on I-10 East		
Participant's Name:	Coalition for Sonoran Desert Protection		
Signature:

Safe Passages for Wildlife on Interstate-10 East of Tucson, Arizona (SR83 to SR90), within the Rincon-Santa Rita-Whetstone Mountains Wildlife Linkage

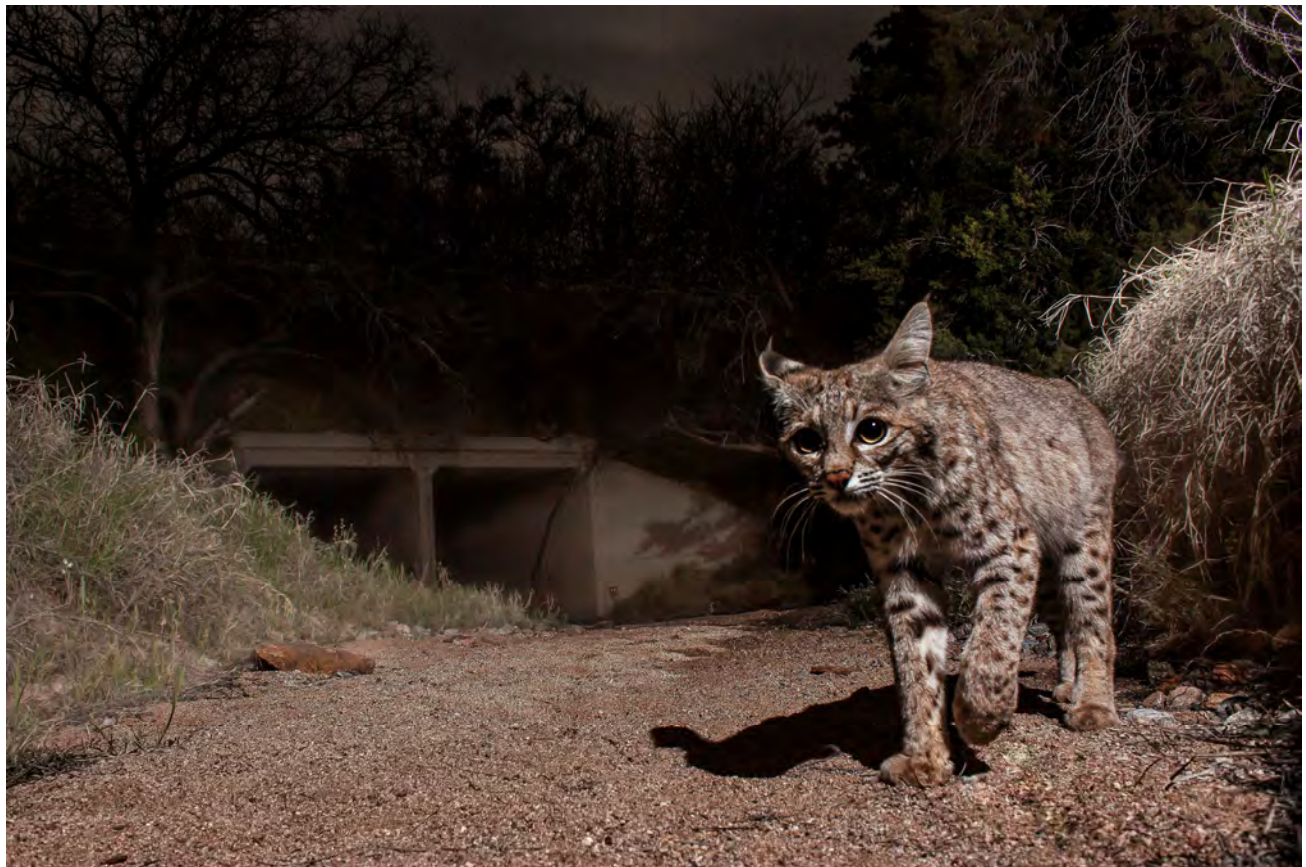
A bobcat walks north through the Site 3 box culvert on I-10 (our project's wildlife camera is visible on culvert wing wall). Photo taken by wildlife photographer Raynor VanDeven with a custom-built camera trap. Raynor's photos provided high quality outreach images to help promote this project.

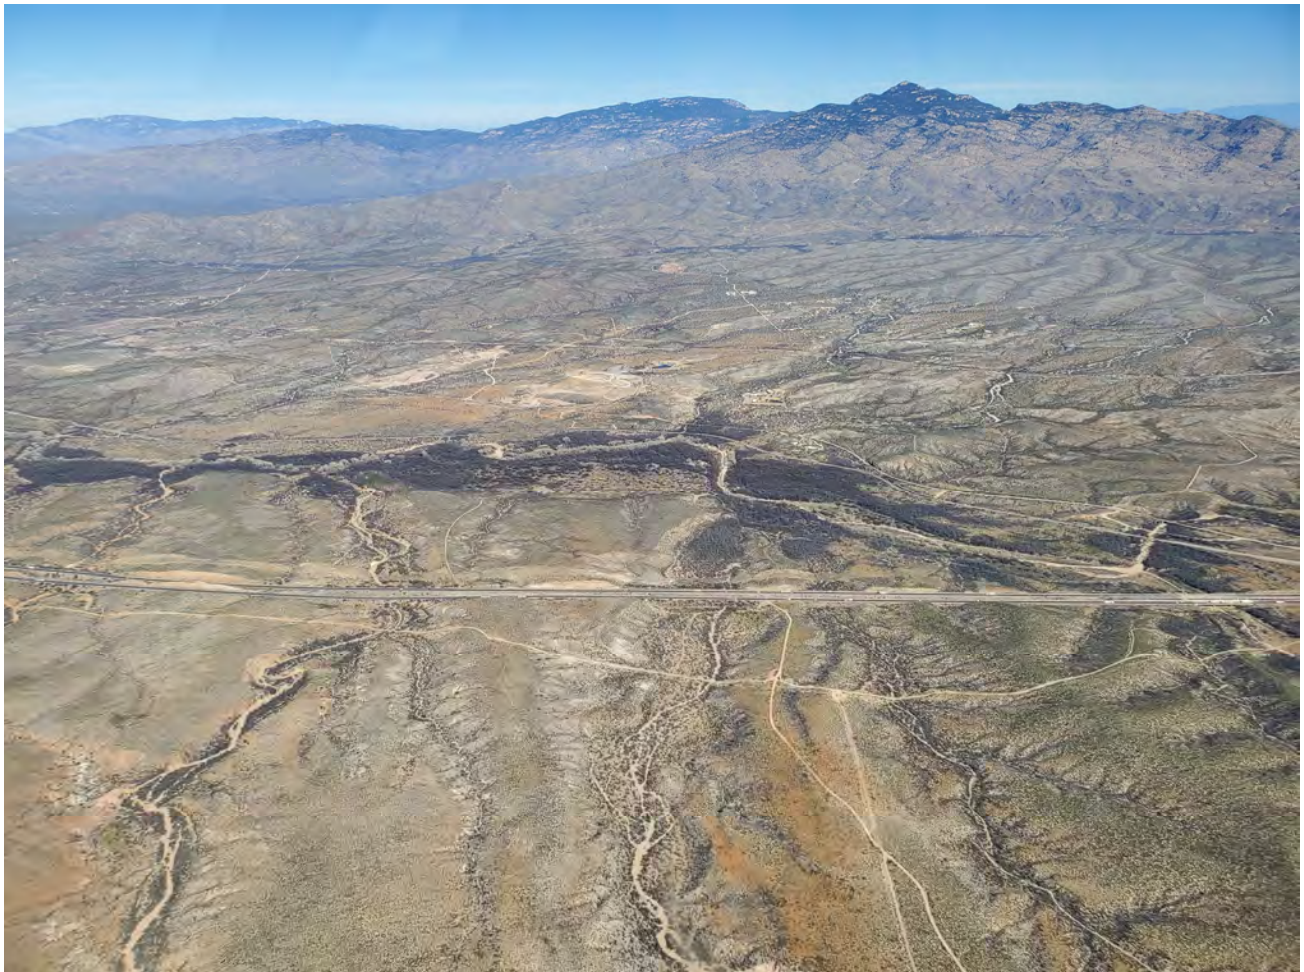
Thanks to aerial support provided by LightHawk, in February 2020 we were able to take to the air and photograph the project study area. The above photo is a view of the Rincon Mountains to the north with Cienega Creek and I-10 in the foreground. The Cienega Creek bridge, on the far center right, is one of the project's monitoring sites, and cameras have been placed at each of the tributary drainages where they cross I-10.

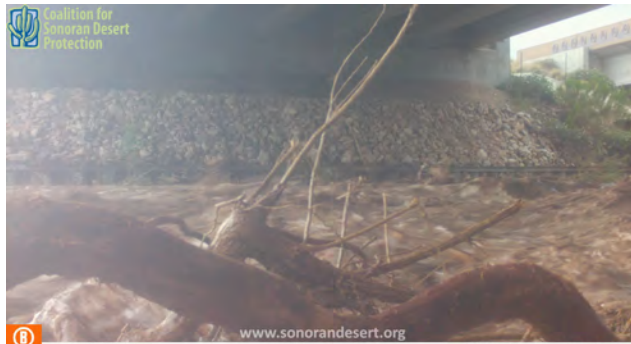
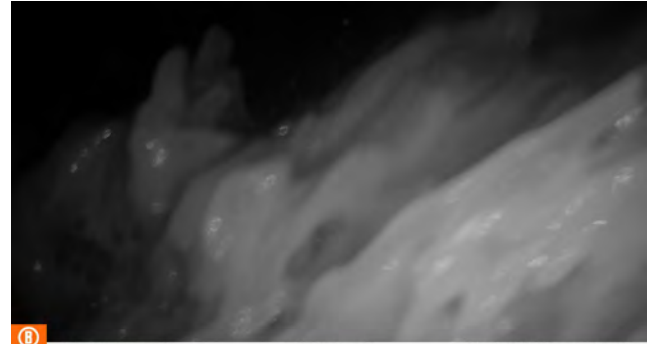
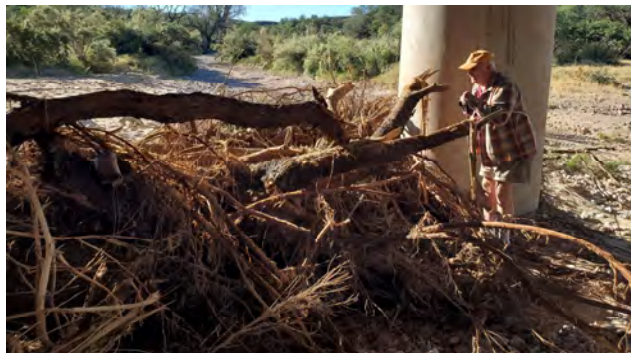
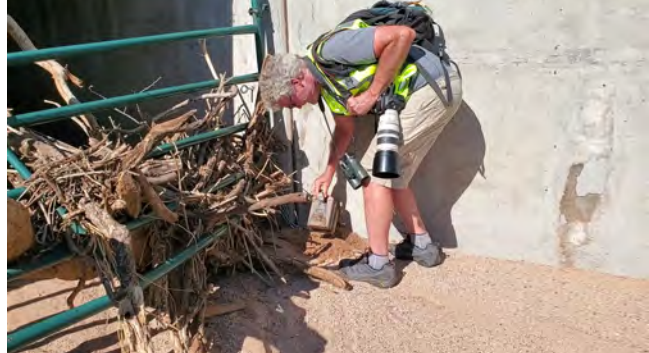
Equipment Loss: In July 2021, we lost an unexpected 21 out of 35 cameras in our project's fleet due to high water and heavy monsoon flooding. Some cameras were scoured off their secured mounts and not recovered, and others were water damaged beyond repair. Pima County's new pipe rail swing gates, designed to allow water and wildlife passage and to exclude cattle and vehicles, were swept downstream or ripped apart. With the remaining functional cameras, and thanks receiving the final 10% of the grant to purchase some additional replacement camera kits, we were able to continue coverage of each of the 8 active study sites, some of which include two separate culverts. For most sites, there is a resulting data gap between July and November.

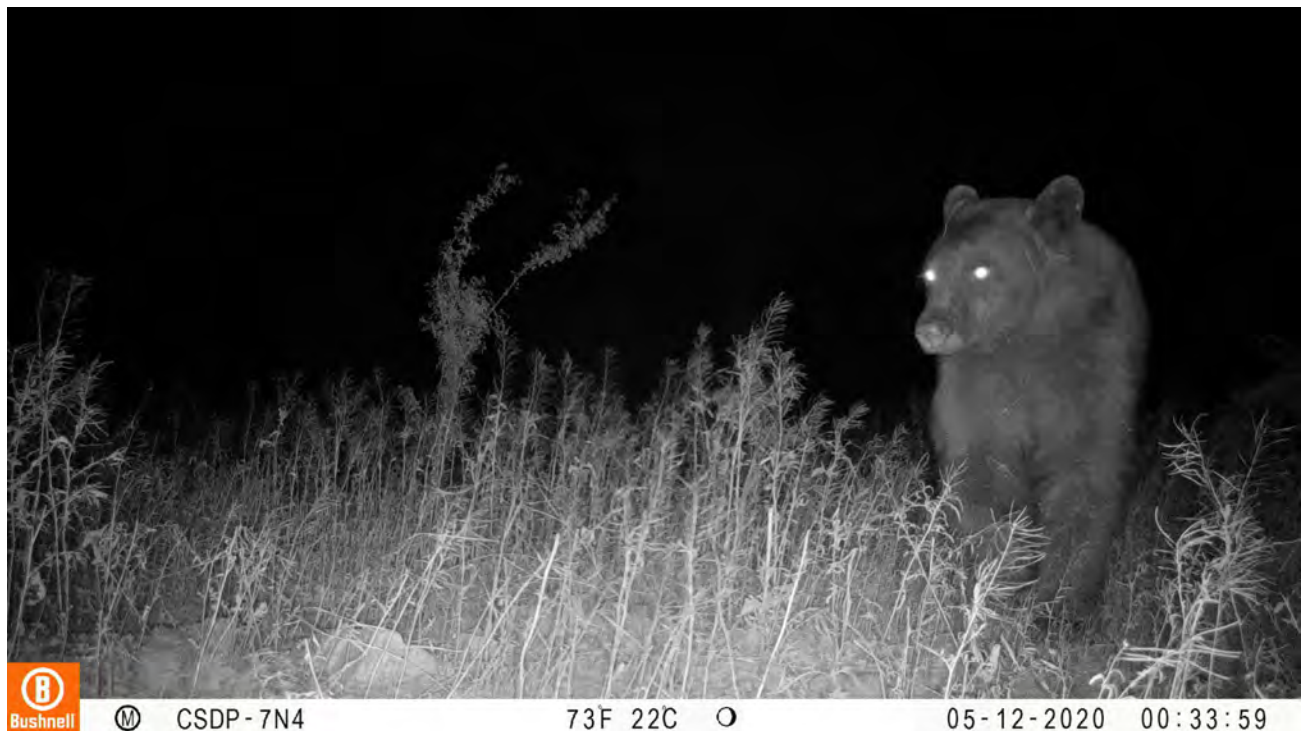
A black bear under the Cienega Creek bridge in May 2020. April-May and August-September appear to be peak periods of activity for black bears in this area according to our data.

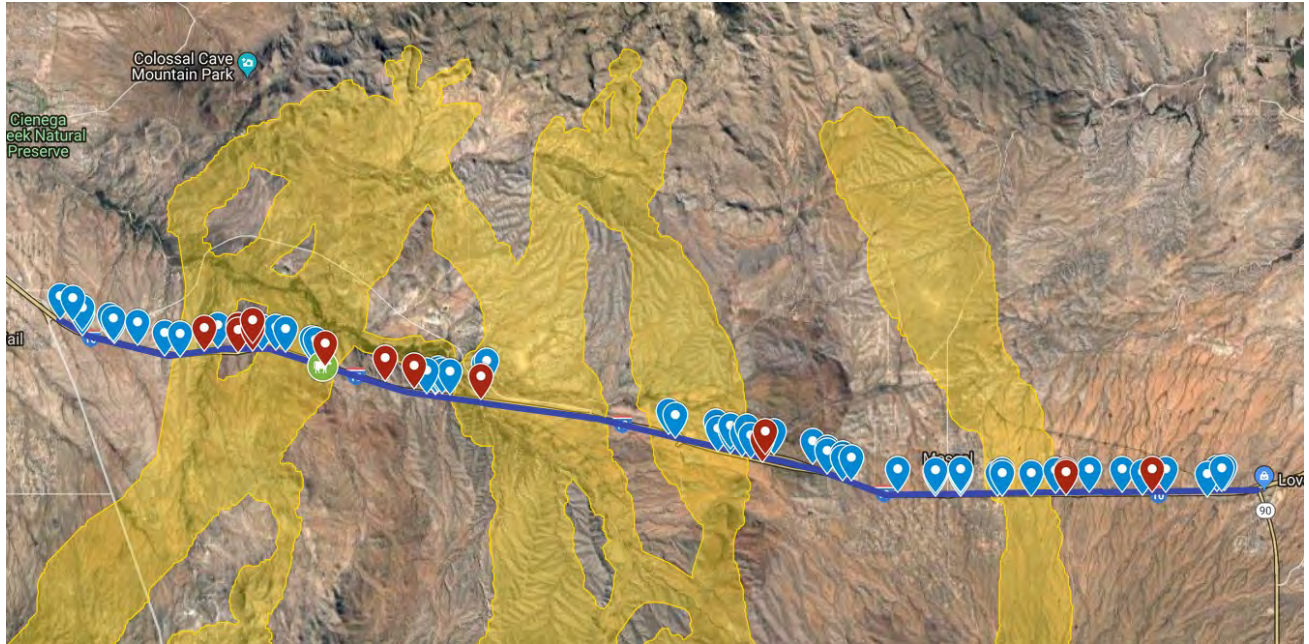
Blue and red pins represent the existing culverts along I-10 between mileposts 281 and 302 (SR83 to SR90). Red pins depict camera monitoring sites chosen for being most conducive to wildlife passage within the wildlife linkage (Beier 2006), shaded in yellow. Notice the absence of any culverts available as crossing points between Cienega Creek bridge and Empirita Rd. This map is available as an interactive map online at <http://bit.ly/SafePassagesI-10East/>.

Wildlife cameras were placed within the ADOT drainage encroachment at the following bridge and culvert locations along I-10:

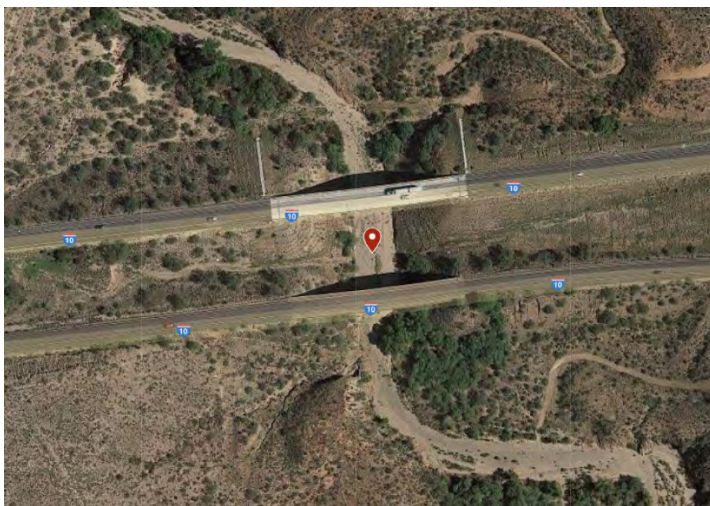
Site 1: Davidson Canyon Bridges

MP 284.45, Davidson Canyon Bridges,
Lat/Long: 31.997605, -110.646033

5 camera placements: In the drainage encroachment, 3 cameras on the south approach and 2 cameras on the north approach.

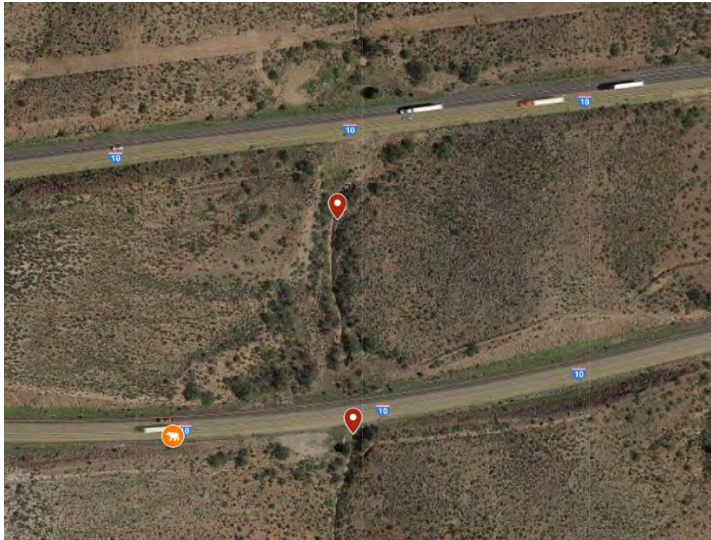
Site 2: Bear Mortality Site

MP 285, Unnamed Double Metal Pipe WB, Lat/Long: 31.998066, -110.636599; and Unnamed RCB (double culvert box) EB, Lat/Long: 31.996965, -110.636508

6 camera placements: In the drainage encroachment, 2 cameras on the south approach and 1 camera on north approach of the Double Metal Pipe WB and 1 camera on the south approach and 2 cameras on north approach at the Unnamed RCB EB. Bats roost in the pipe culvert for part of the year.

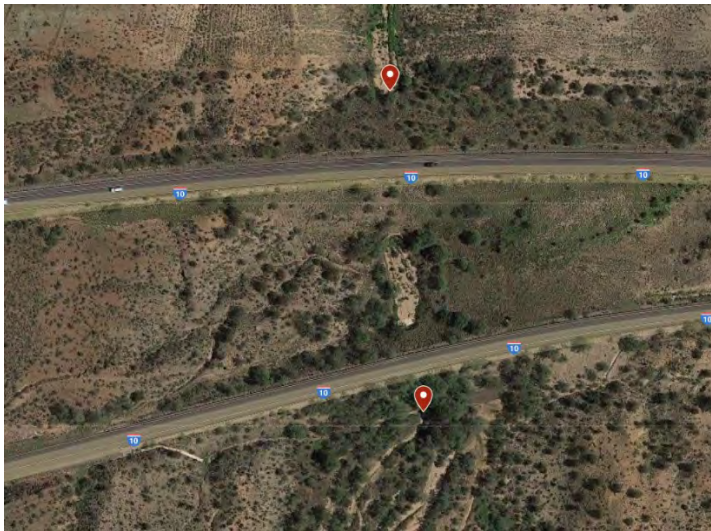
Site 3: Blue Nob Canyon

MP 285.24, Blue Nob Cyn RCB EB, Lat/Long: 31.9993527, -110.6323842; and MP 285.24, Blue Nob Cyn RCB WB, Lat/Long: 31.997674, -110.632175

4 camera placements: In the drainage encroachment, 1 camera on the south approach and 1 camera on the north approach of RCB EB and of RCB WB.

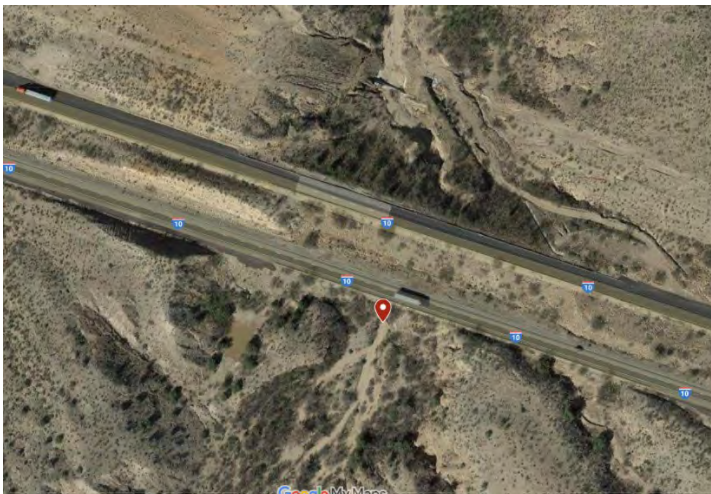
Site 4: Cattle Tank Site

MP 288.05, Unnamed RCB, Lat/Long: 31.993914, -110.611579

2 camera placements: In the drainage encroachment, 1 camera on the south approach and 1 camera on north approach of the culvert.

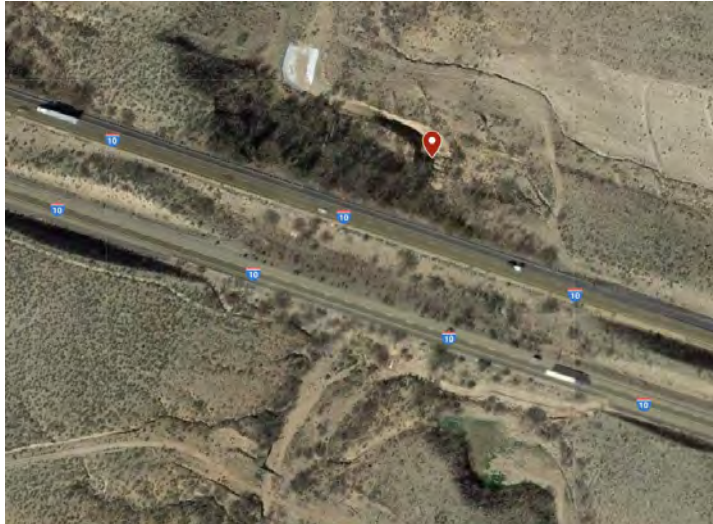
Site 5: Culvert Spring Site

Unnamed RCB, Lat/Long: 31.9902199, -110.5947143

2 camera placements: In the drainage encroachment, 1 camera on the south approach and 1 camera on north approach of the culvert. This site has an active seep at the south entrance to the eastbound culvert, which was assessed in a springs biological assessment in 2017 by Sky Island Alliance.

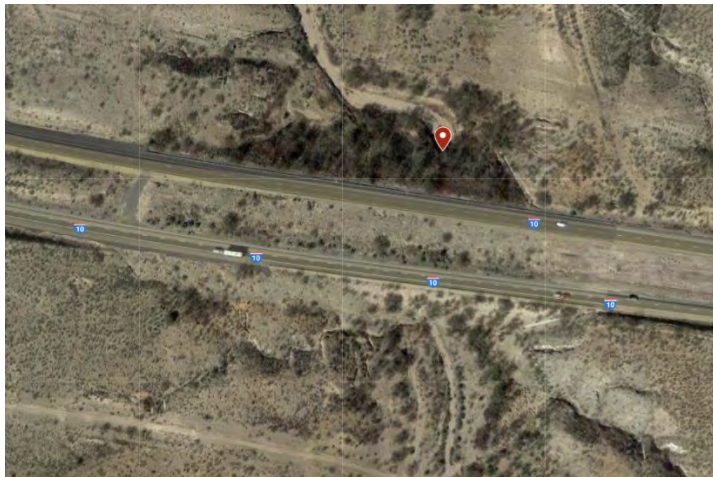
Site 6: Turner Site

Unnamed RCB, Lat/Long, 31.9884431, -110.5863324

2 camera placements: In the drainage encroachment, 1 camera on the south approach and 1 camera on north approach of the culvert.

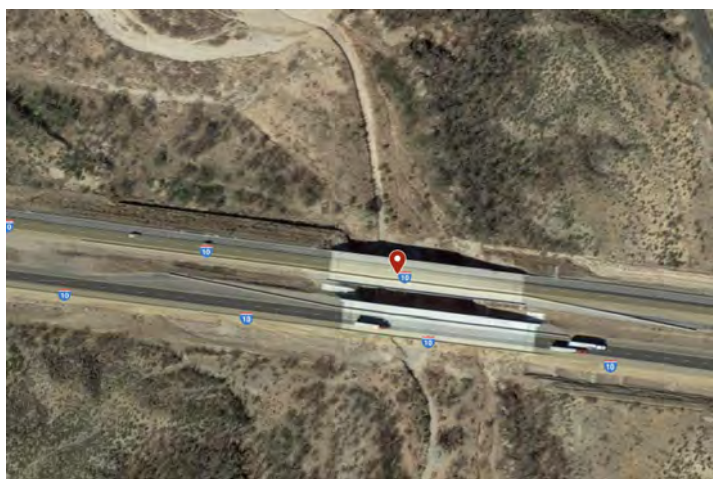
Site 7: Cienega Creek Bridges

MP 289.2, Cienega Creek Bridges, Lat/Long: 31.9859854, -110.5674212

10 camera placements: In the drainage encroachment, 6 cameras on south approach and 4 cameras on north approach. Additional cameras were needed here due to the width of the drainage.

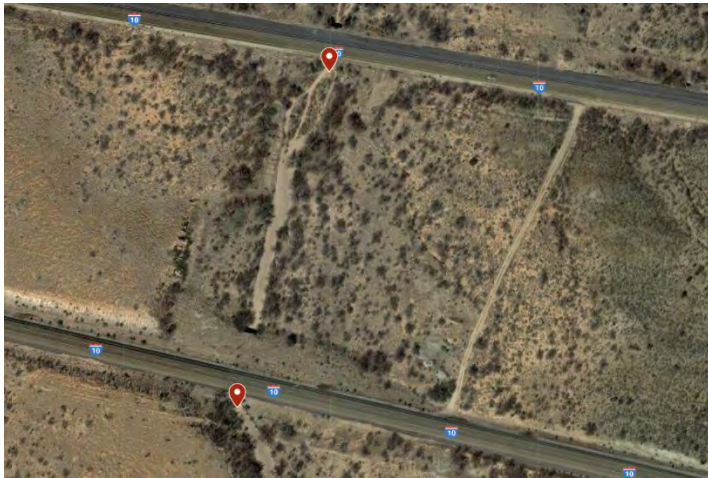
Site 8: Speeden Wash

MP 294.01, Speeden Wash RCB EB, Lat/Long: 31.970747, -110.487384; and Speeden Wash RCB WB, Lat/Long: 31.97263, -110.48677

4 camera placements: In the drainage encroachment, 1 camera on the south approach and 1 camera on the north approach of RCB EB and of RCB WB. There is a closed cattle gate at the north entrance to the westbound culvert.

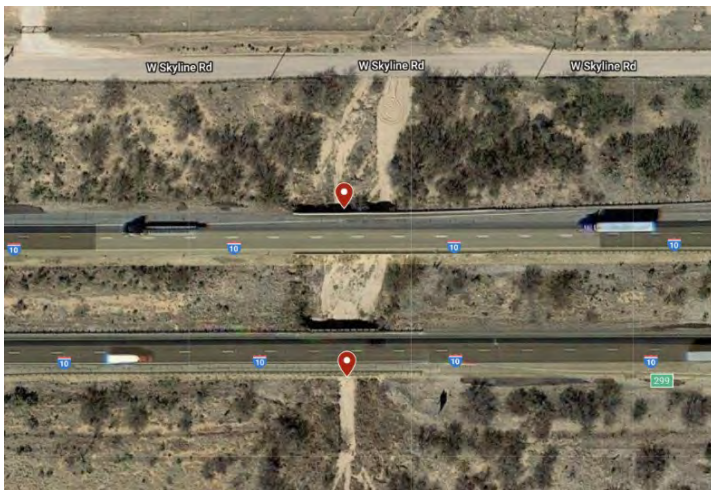
Site 9: Skyline

Unnamed WB, Lat/Long: 31.96329, -110.40113; and Unnamed EB, Lat/Long: 31.96285, -110.40112

8 camera placements: In the drainage encroachment, 2 cameras on south approach and 6 cameras on north approach. Additional cameras were needed here due to the width of the drainage and the culvert's multiple boxes.

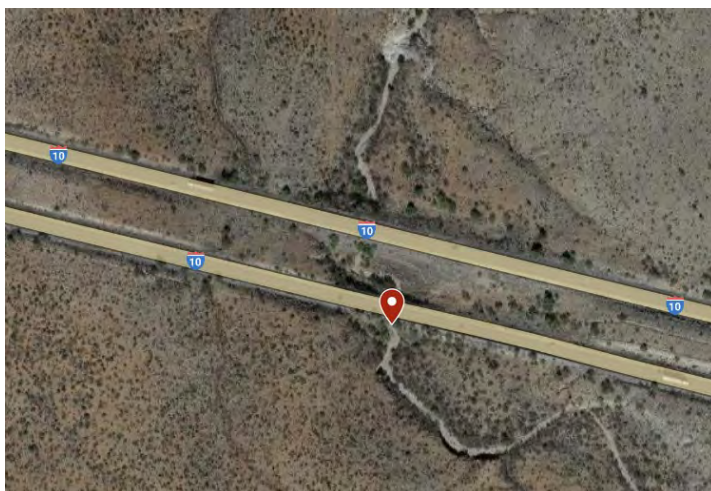
Site 10: Swing Gate

Unnamed RCB, Lat/Long: 31.99936, -110.67156

2 camera placements: In the drainage encroachment, 1 camera on the south approach and 1 camera on the south swing gate set back 40 feet from culvert. This site was added to assist Pima County in monitoring new swing gate effectiveness for wildlife and to help monitor property damage.
