**Nearly a decade later:  
Assessing the condition of the Oracle Road wildlife funnel fence  
August 2025**

**Background:**

The Arizona Department of Transportation (ADOT) installed wildlife funnel fencing in 2016 on Oracle Road/State Route 77, near Catalina State Park north of Tucson, Arizona. The fence extends for roughly four miles from East Thistle Road to East Thornydale Road (southbound lane/west fence), and four miles from East Canyon Springs Place to East Wilds Road (northbound lane /east fence). Approximately one mile of the wire mesh wildlife funnel fence on the west side is replaced instead by a concrete block sound wall, from just north of North Big Wash Overlook Place to East Vistoso Commerce Loop Road.

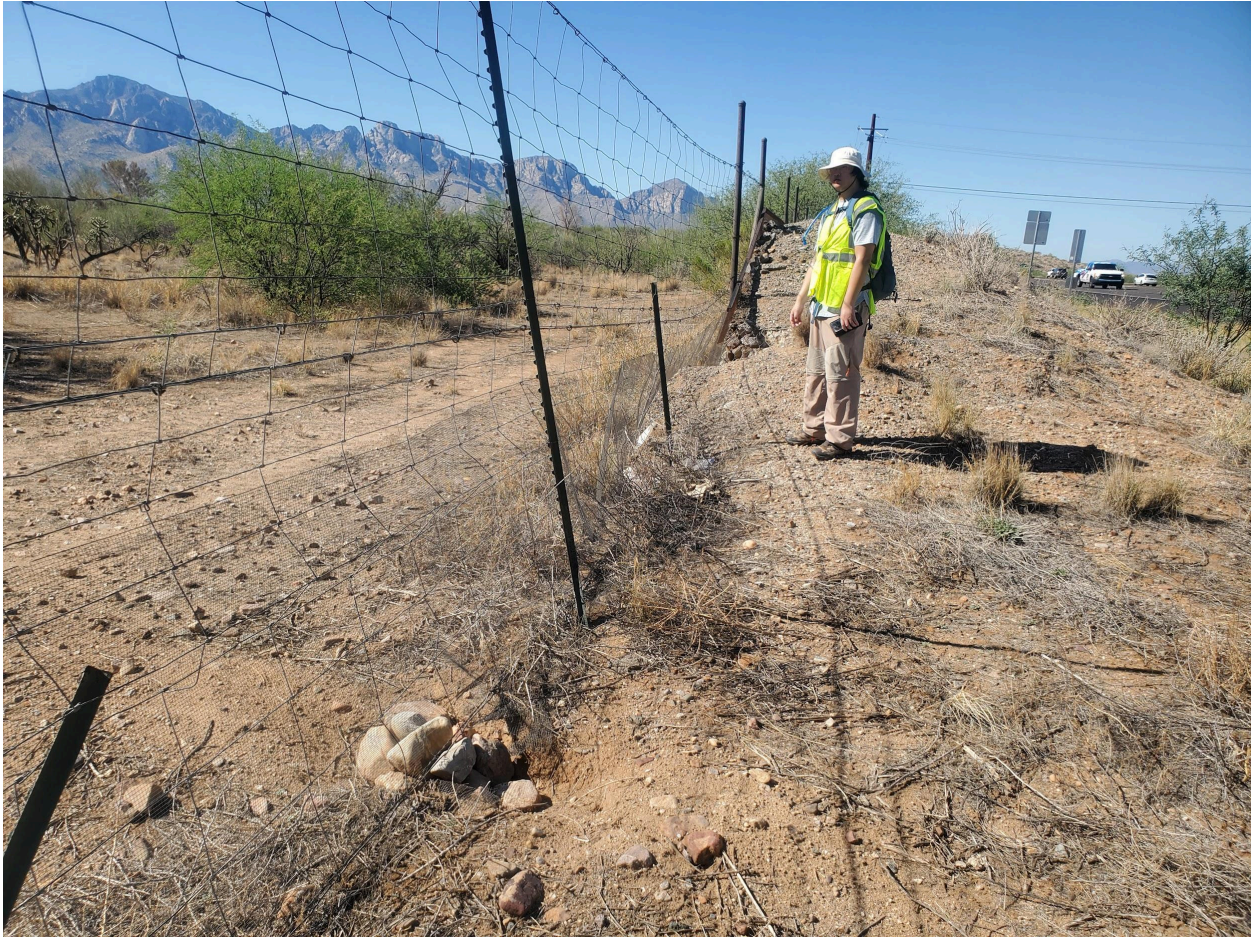
*Northbound fence line located at 32.472264, -110.923503, collision damage to fence and posts that had been patched back together. One smaller opening was partially repaired with rocks.*

- Where vehicle collisions caused fence damage, we noted that the fence had been partially patched back together using the existing fencing materials onsite.

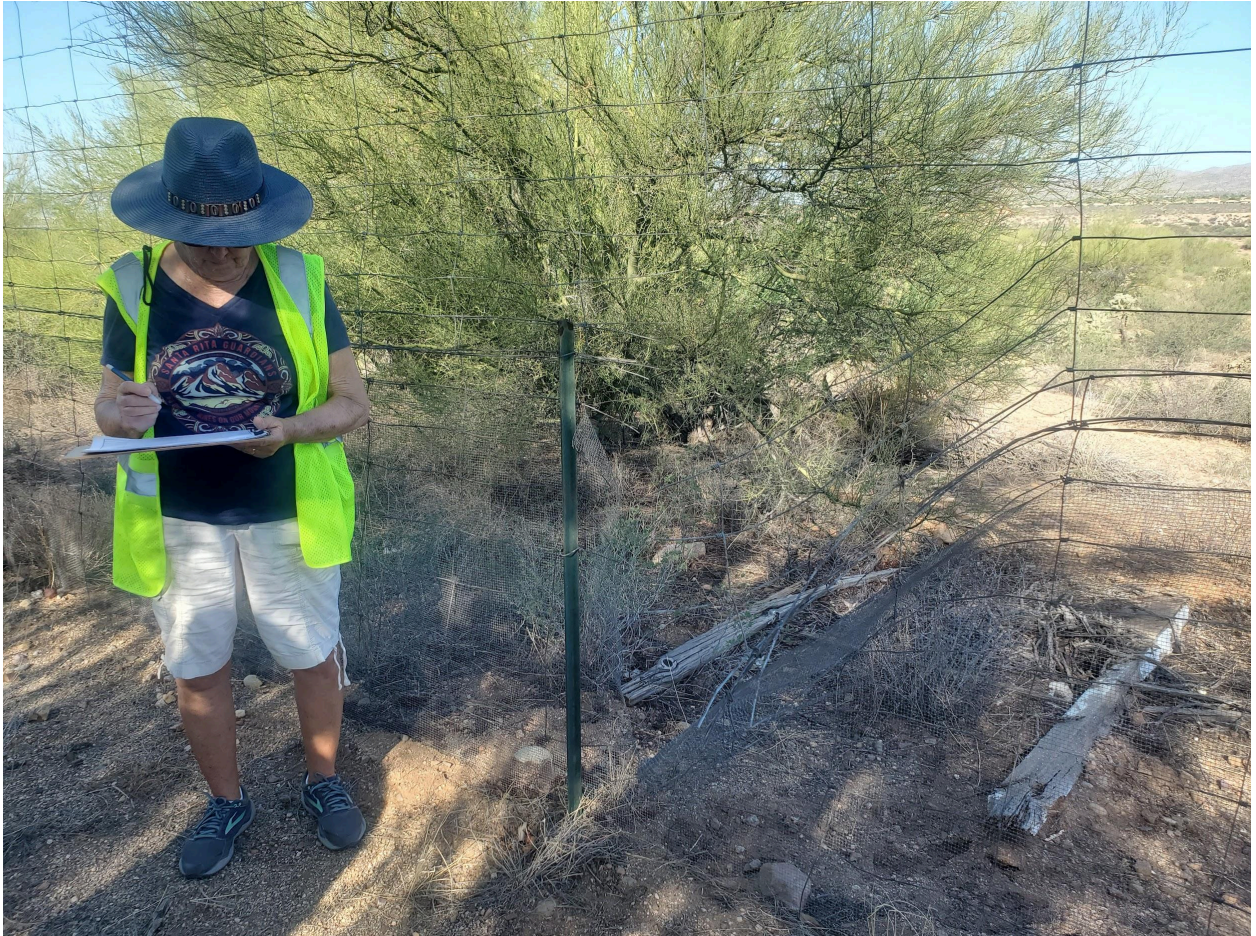
*South of the wildlife bridge at 32.466672, -110.926108, close to the waste transfer station driveway. Opening large enough for people. The wire was cut deliberately but requires stepping over. Javelina tracks present here on both sides of the fence.*

- Both cases of vandalism appeared to be from someone cutting doors or openings in the fence to give people access to step through.

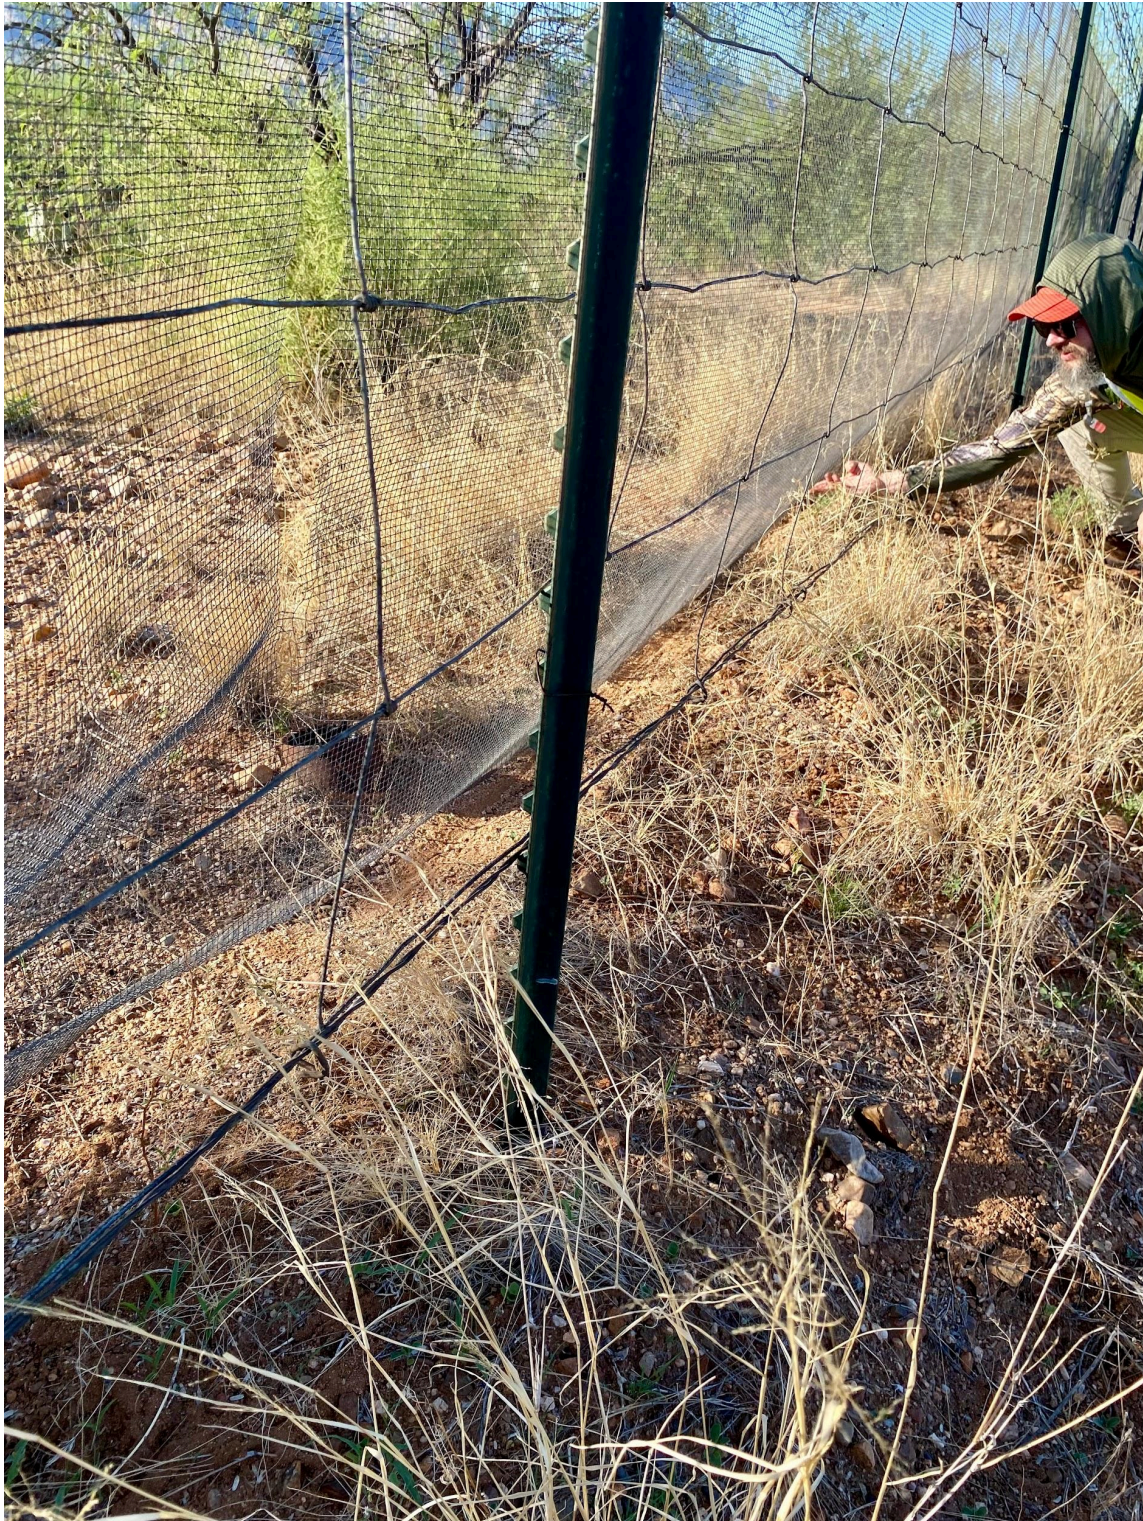
*Mesh footing has come loose allowing animals to push through or crawl under the fenceline at 32.452782, -110.932226. Needs reburied.*

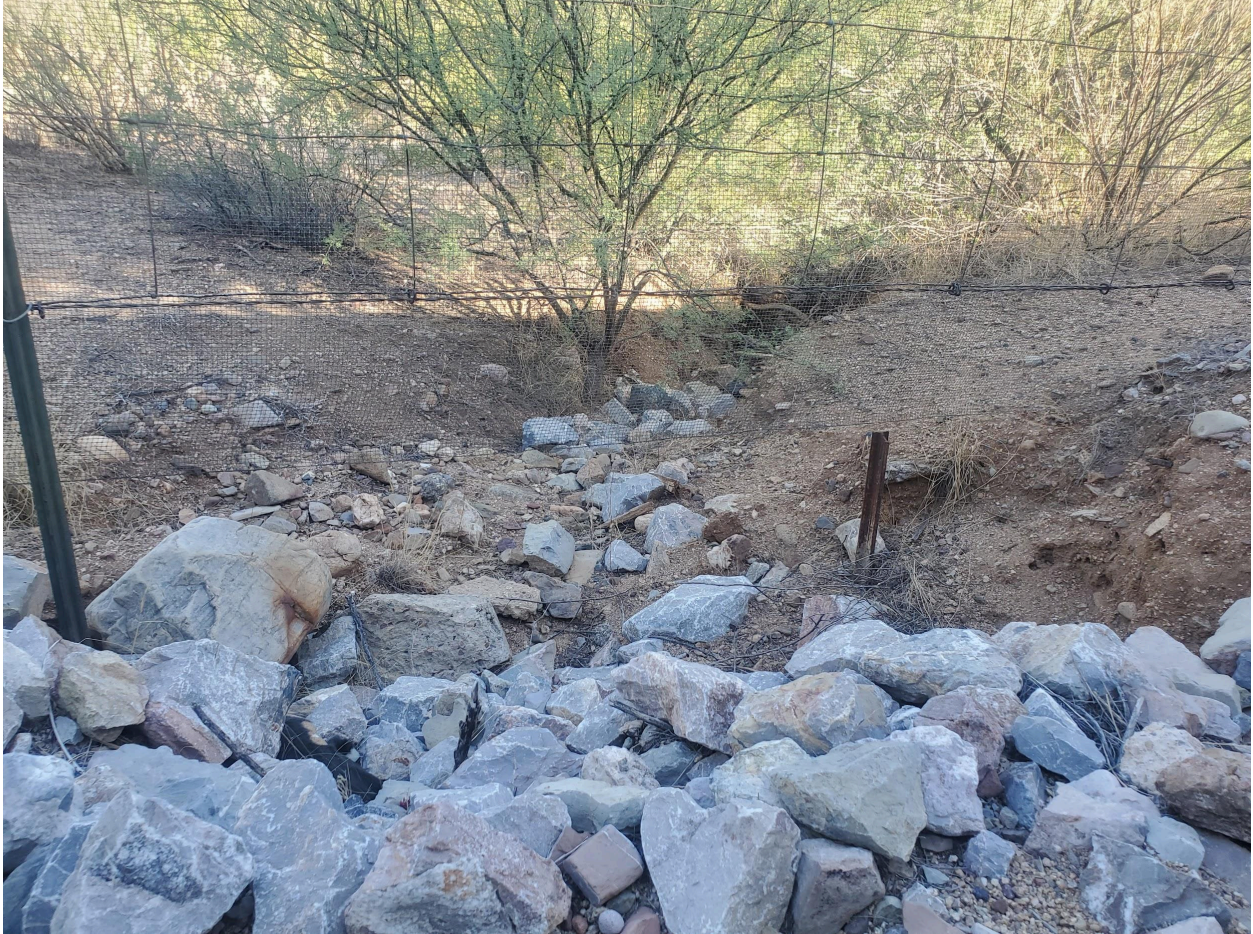
*Erosion from a pipe culvert was hindered by rip rap, located at 32.461706, -110.927892, but still eroded a three-foot wide opening near the mouth of the culvert, creating an opening large enough for coyotes or javelina to use.*

- **Breaks occurred most often and more severely where drainage pipes opened inside of the right of way**, rather than outside of the fence; a lesson learned for future projects.

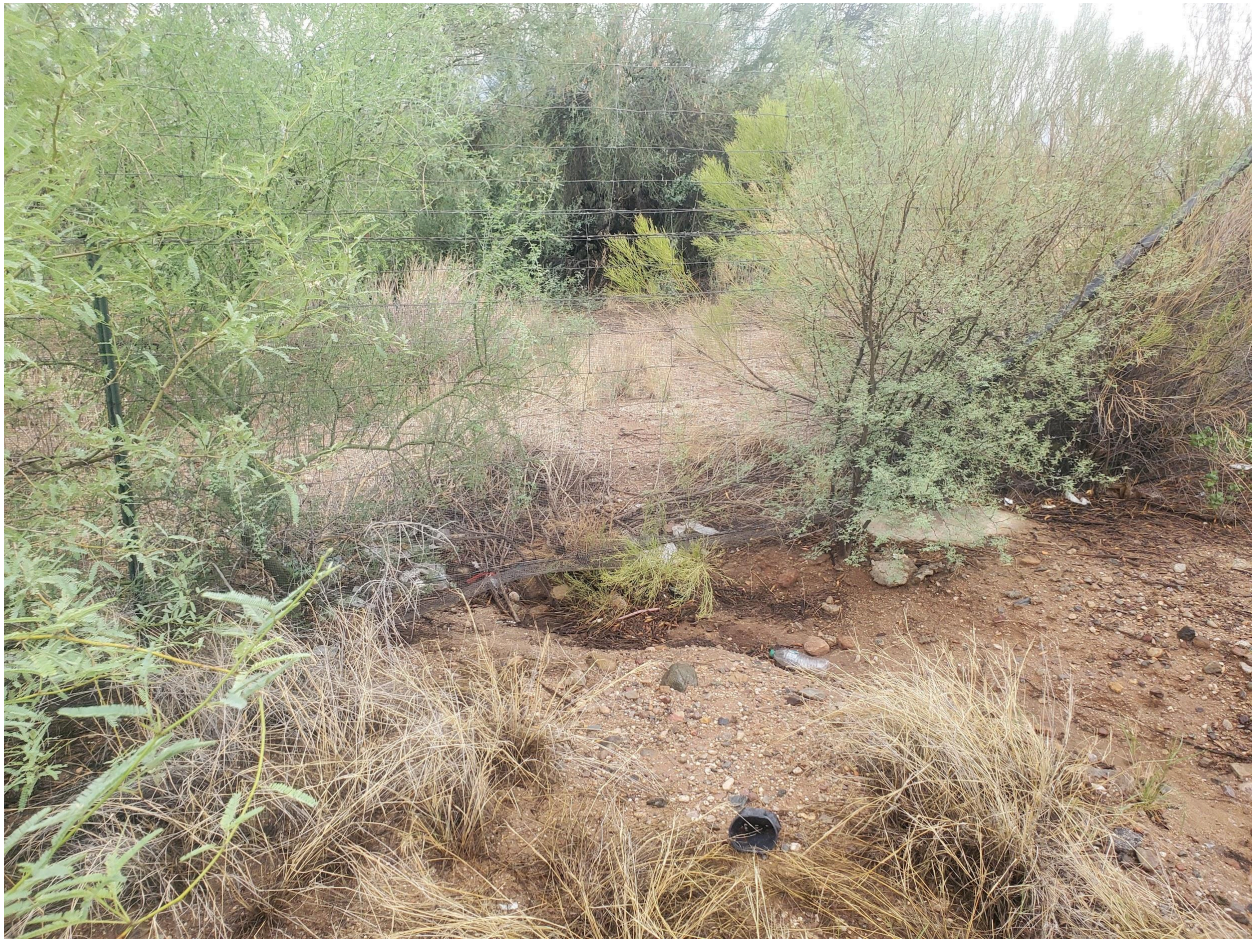
*Near the Oracle Road/Wilds Road intersection, at 32.474369, -110.922778, water from a nearby pipe culvert has washed out an opening under this part of the wildlife fence big enough to accommodate small to medium-sized animals.*

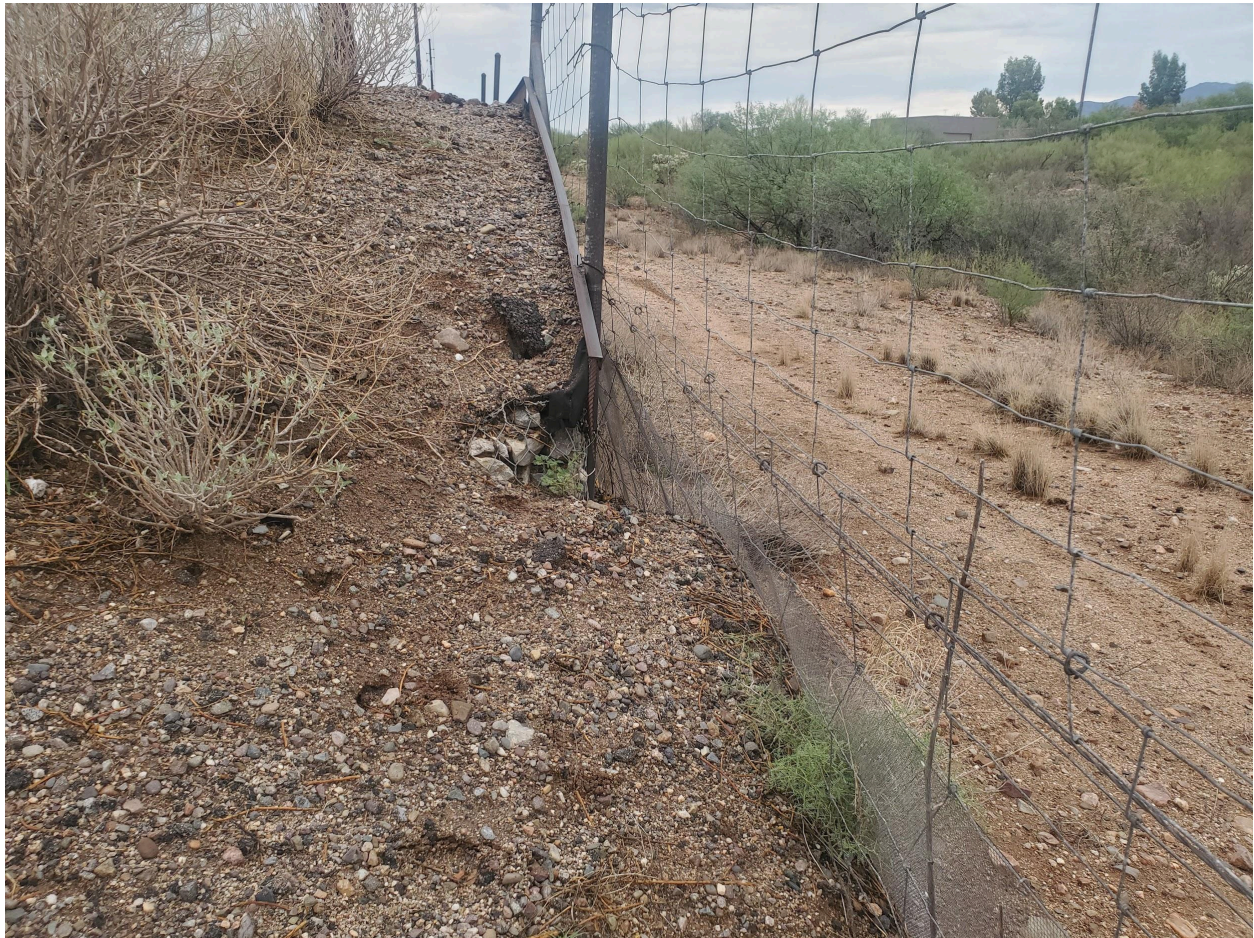
*The soil embankment is eroding on this wildlife jump out at 32.461619, -110.927108, and dirt is slowly pushing the mesh footing outwards. This was tagged as low priority, but could soon become a problem.*

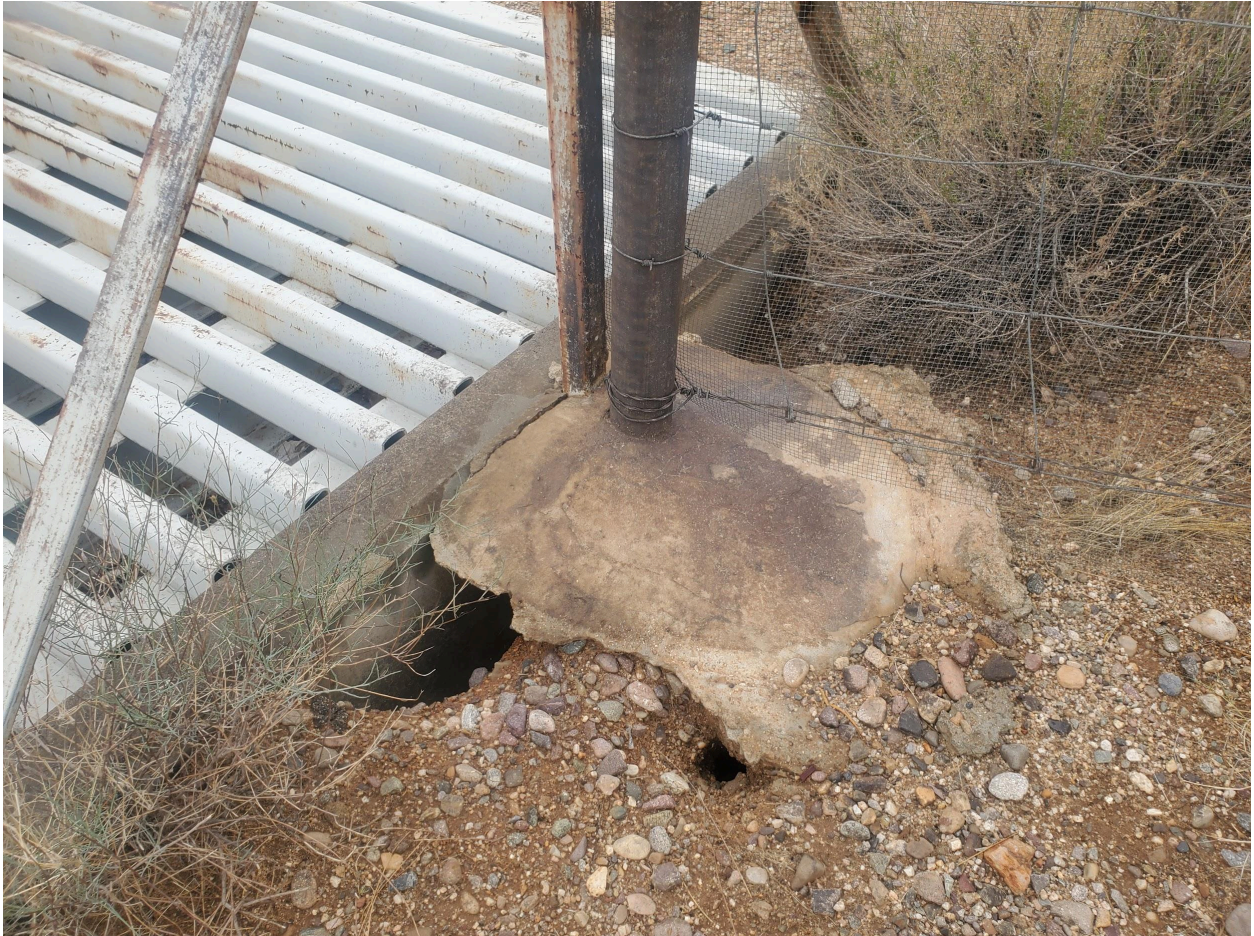
*Erosion and animal digging created a tunnel all the way underneath this concrete footing, located at a cattle guard at 32.459994, -110.927992. Small to medium sized animals (including rodents, rabbits, snakes) can gain access. For future projects, we also suggest that the end point of the fence be tied to, or continue along, the horizontal edge of the cattle guard so larger animals can't just step around the post.*

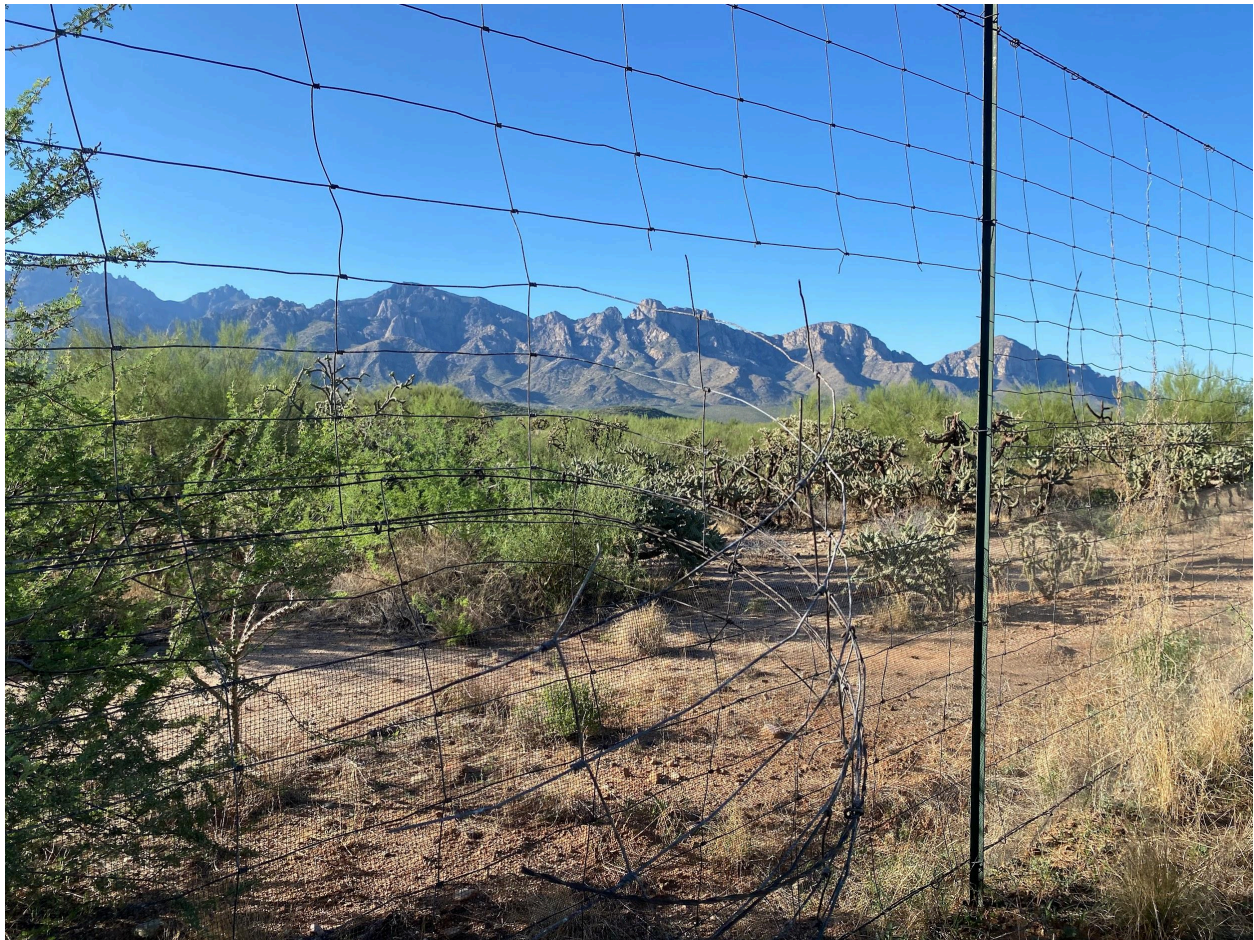
*Another large opening cut into the fenceline located at 32.455001, -110.930830.*

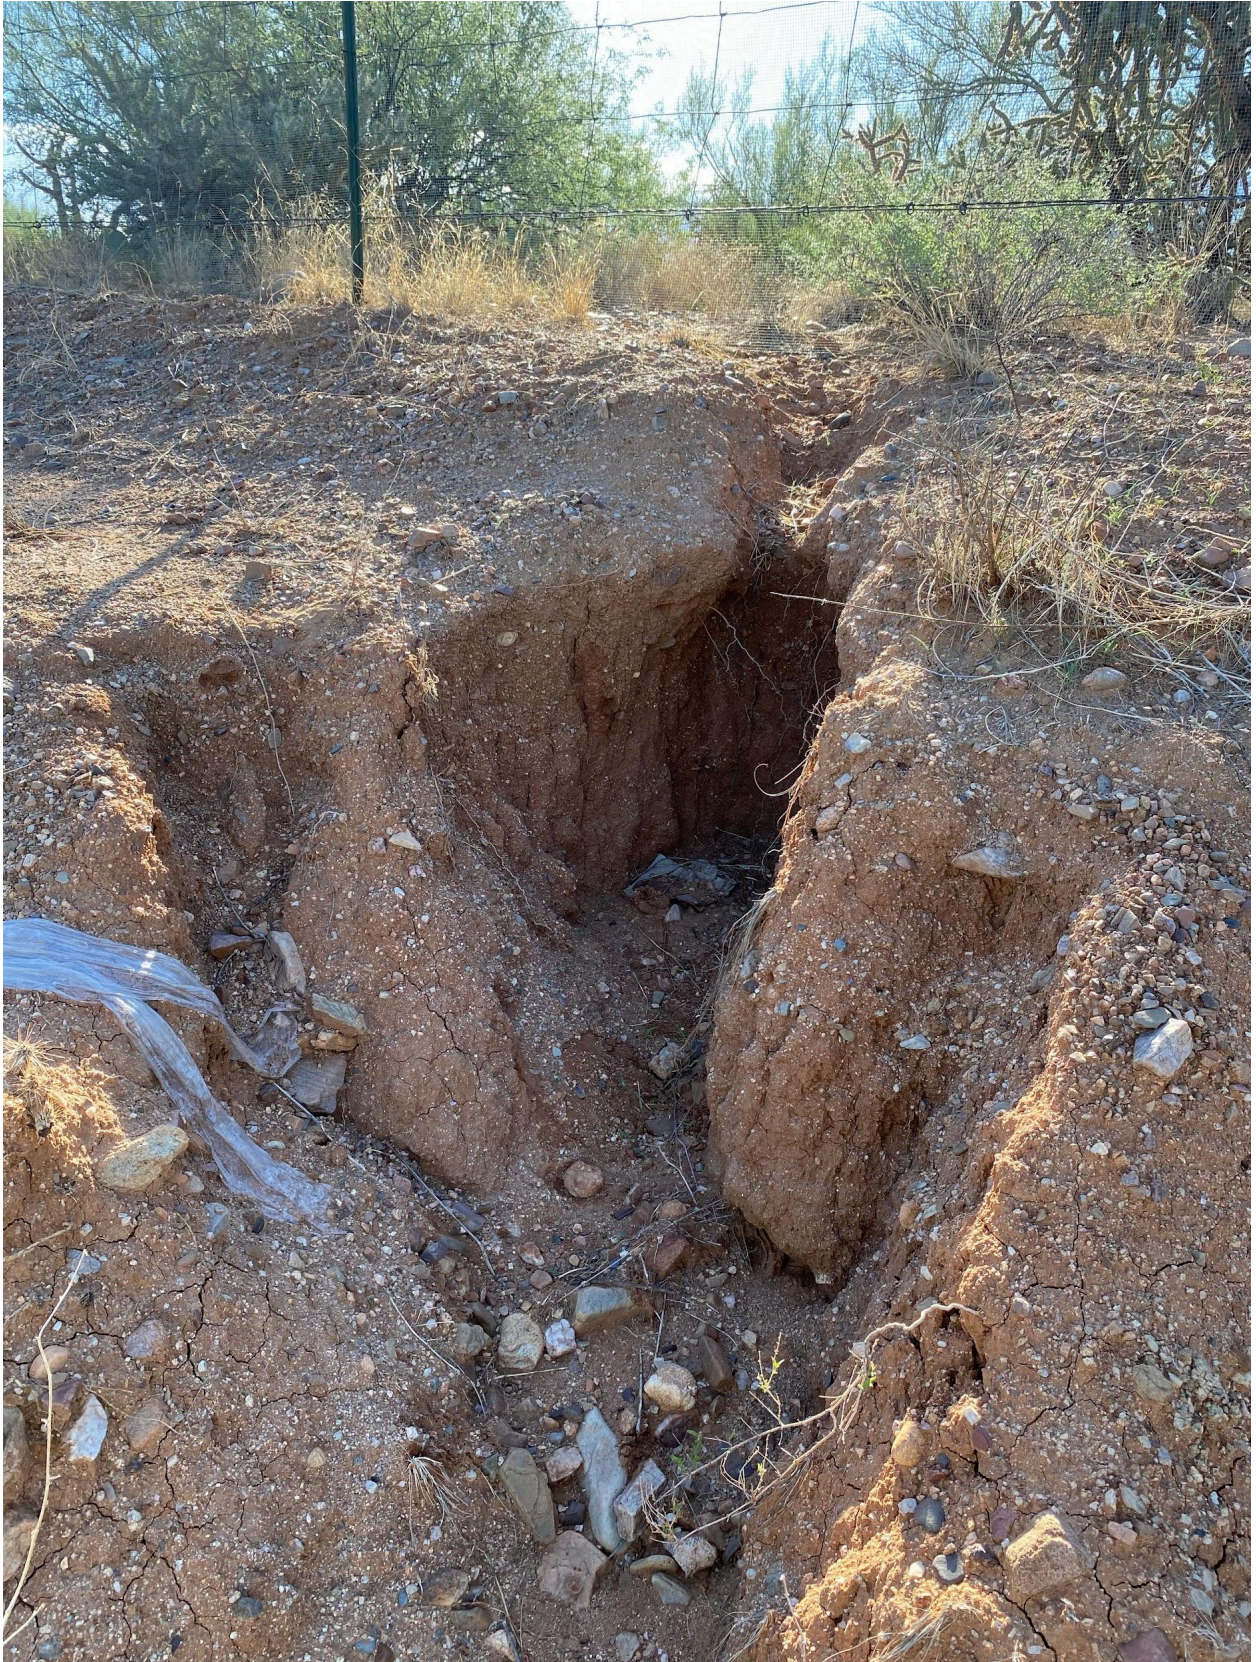
*Erosion caused this opening, located at 32.452782, -110.932226.*

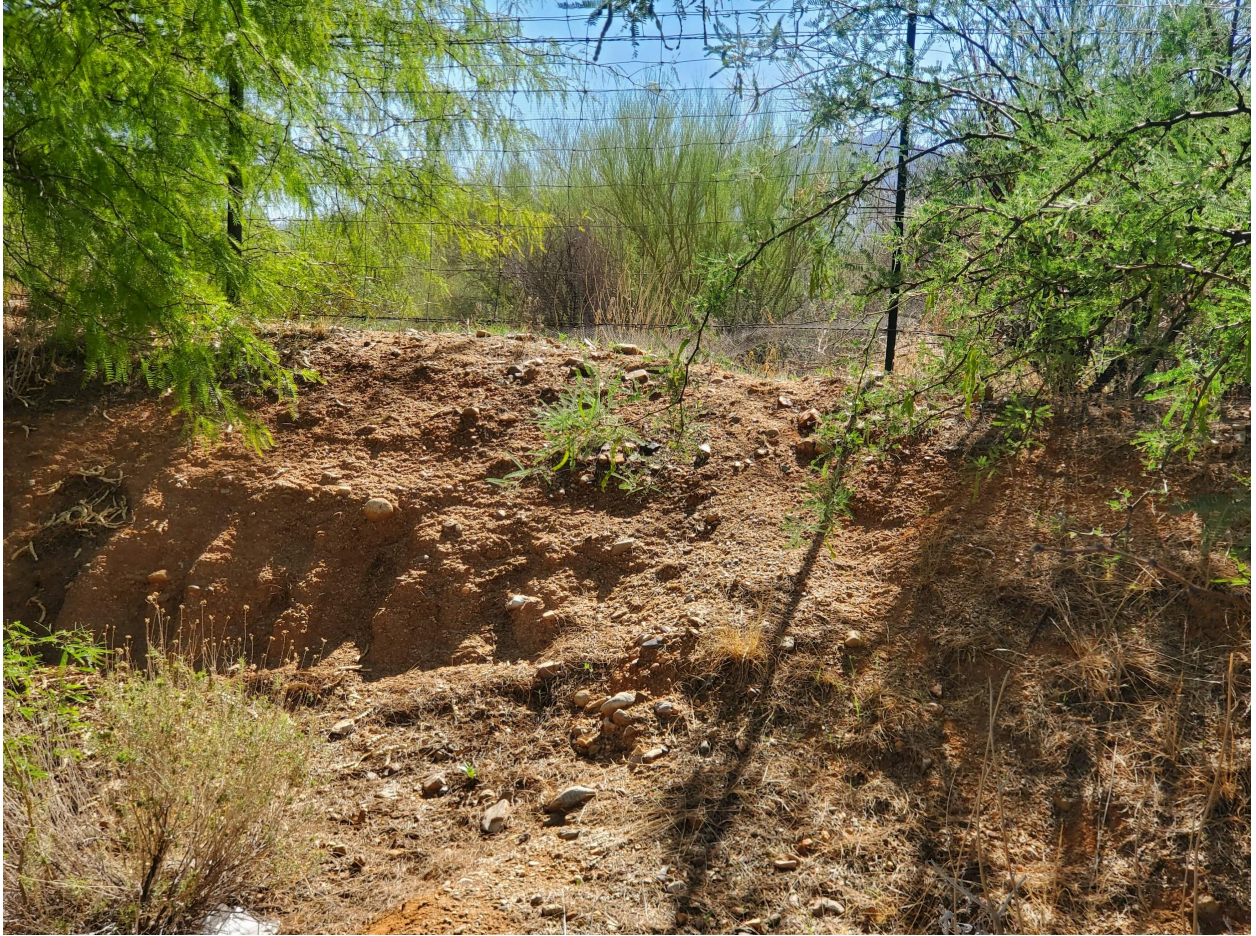
*A break in the fence at 32.464717, -110.926284, likely animal-caused, is large enough for small animals or a tortoise to access. Animal tracks and trails showed recent use by rodents.*

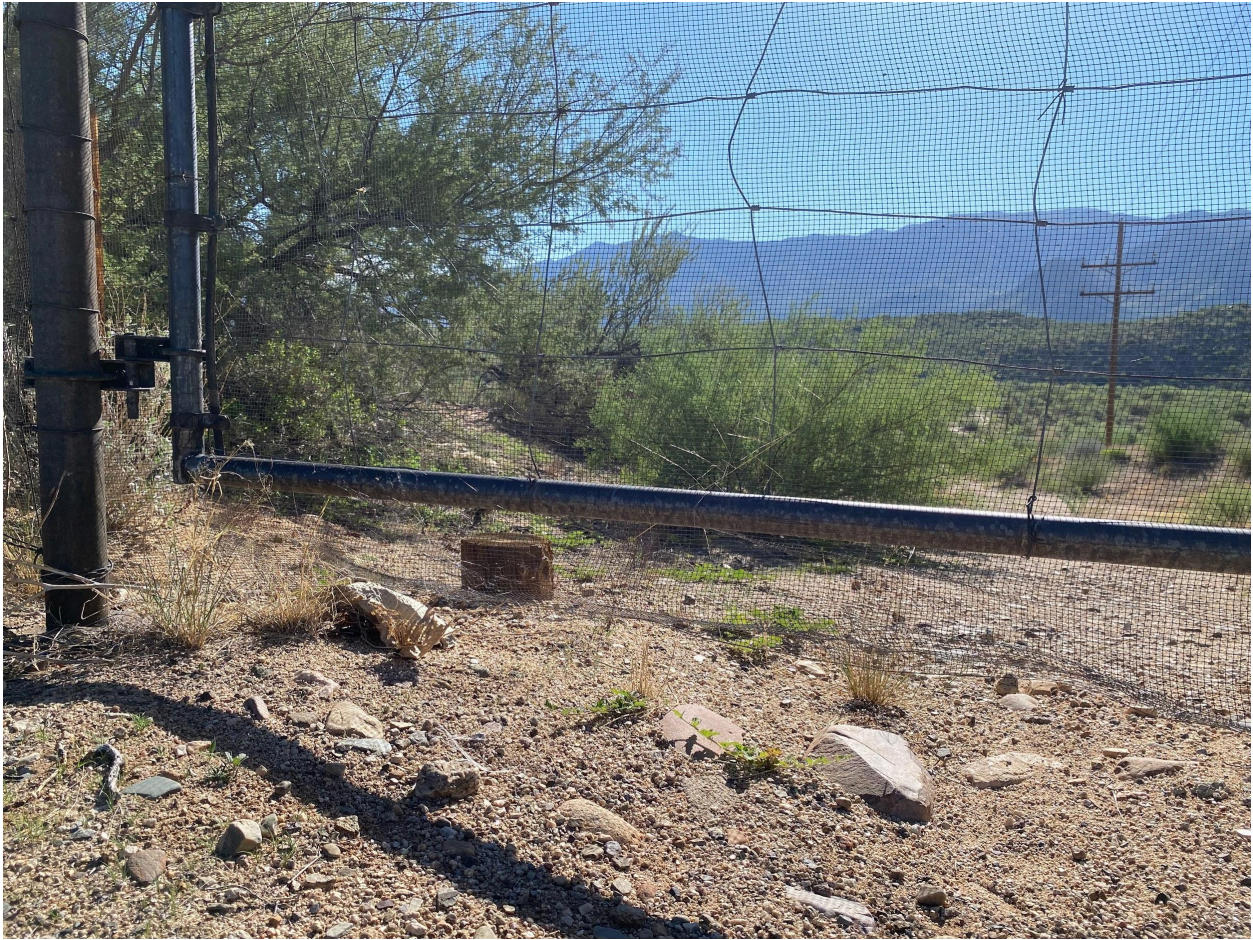
*These structural issues are a weak point, where gates just have the mesh footing laid down on the ground instead of being buried. Over time, animals or just regular use can move the mesh up enough for animals to push underneath. 32.438051, -110.933609.*
