## Tucson – Tortolita Mountains Wildlife Linkage Monitoring Project

### 2025 Annual Report

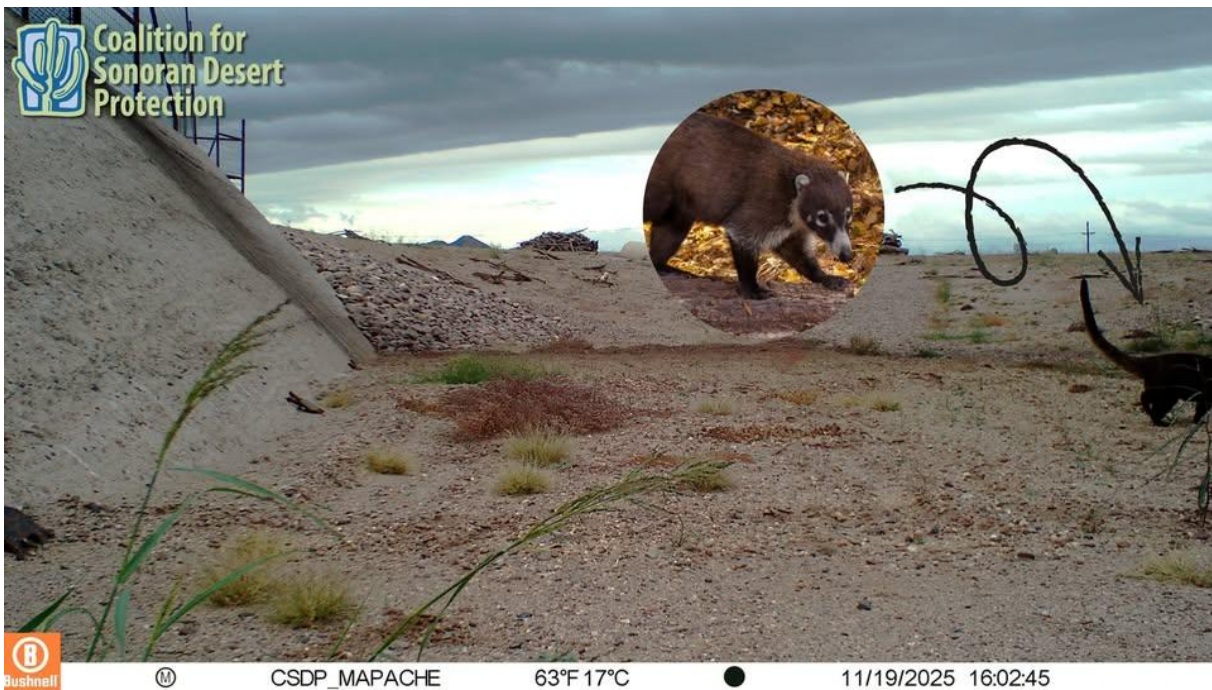
*Figure 1. A white-nose coati was documented in November 2025 exploring the new wildlife ramp. Coatis, likely all males, have only been documented 4-5 times in the Tucson Mountains, most associated with the Santa Cruz River.*

The photo of a coati at the wildlife ramp was surprising to see due to the rarity of coatis in this area, since coatis prefer higher elevation habitat found in the Tortolita and Catalina mountains, and wooded riparian corridors. Five days before this photo was taken, one of our Desert

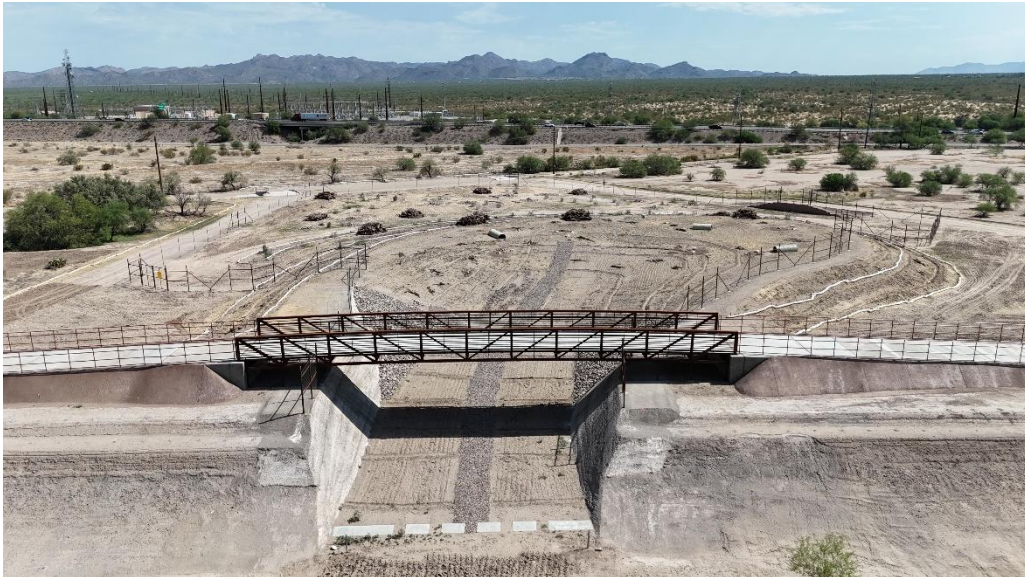
*Figure 4. The newly completed wildlife ramp, with the 1-10 railroad underpass and Tortolita Mountains visible in the upper right corner. Photo by Nanda Srinivasamurthy.*

In 2025, the wildlife ramp was constructed. It has been fenced off to provide only east to west passage via strategically placed jump outs and to avoid funneling wildlife onto the open highway. This same year, we successfully expanded the project to include the ramp, railroad underpass, and core habitat at either end of the Linkage, for a total of nine stratified study areas and 40 cameras. The ramp and underpass each have 6 cameras to collect accurate passage rate data, and the other strata each contain 4 cameras.

- **2025** - Pima County's wildlife ramp is completed and cameras are added to the ramp and railroad underpass to monitor wildlife use and passage rates at these chokepoints, and in Saguaro National Park for comparison of core habitat with the linkage.

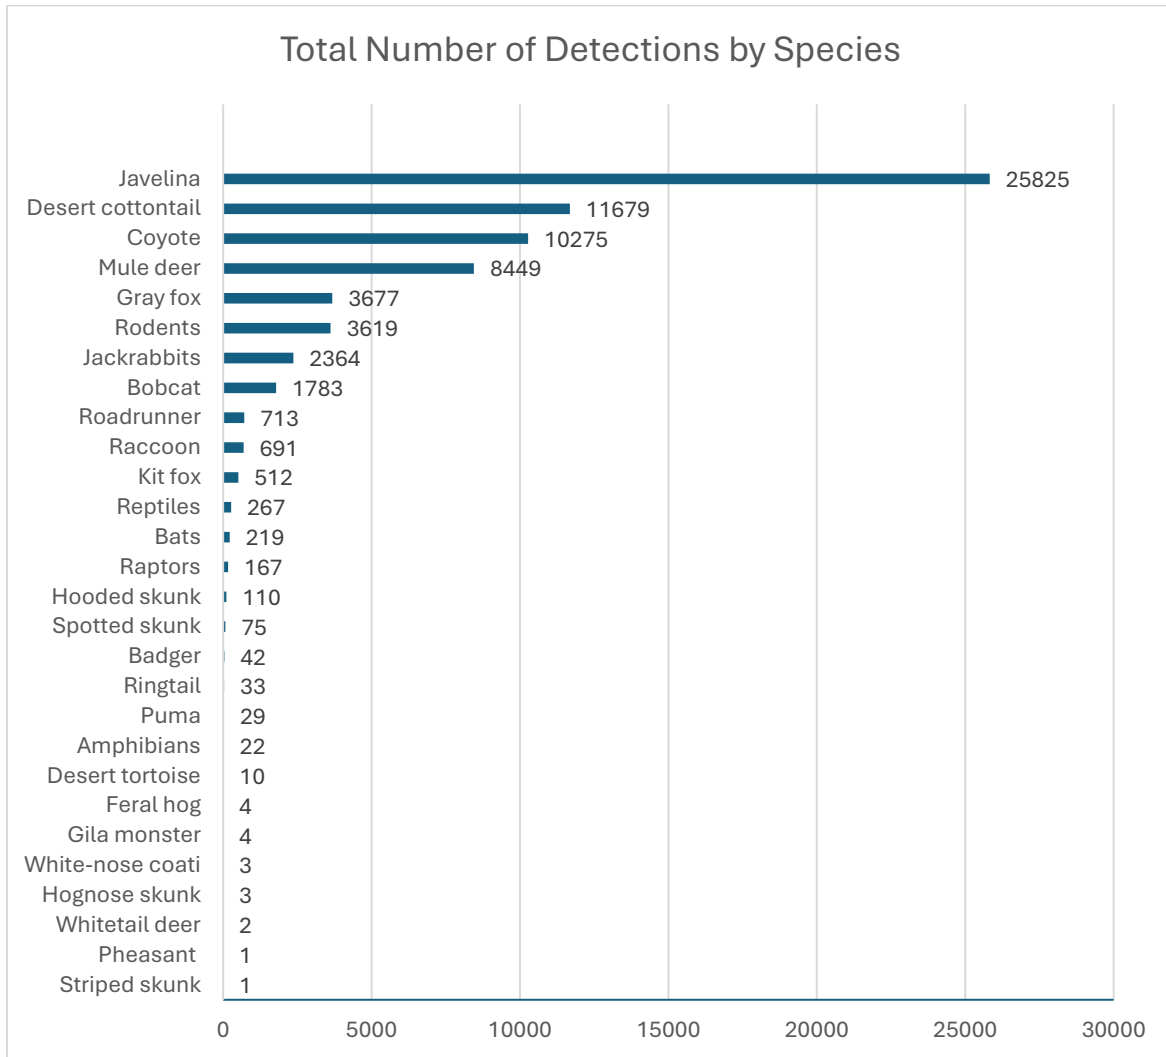
*Figure 5. There were a total of 175,324 photos processed resulting in 110,140 verified wildlife photos and 45,902 species detections across all study areas combined. Birds, making the majority of photo records, and some other species including humans, were removed from this figure for clarity.*

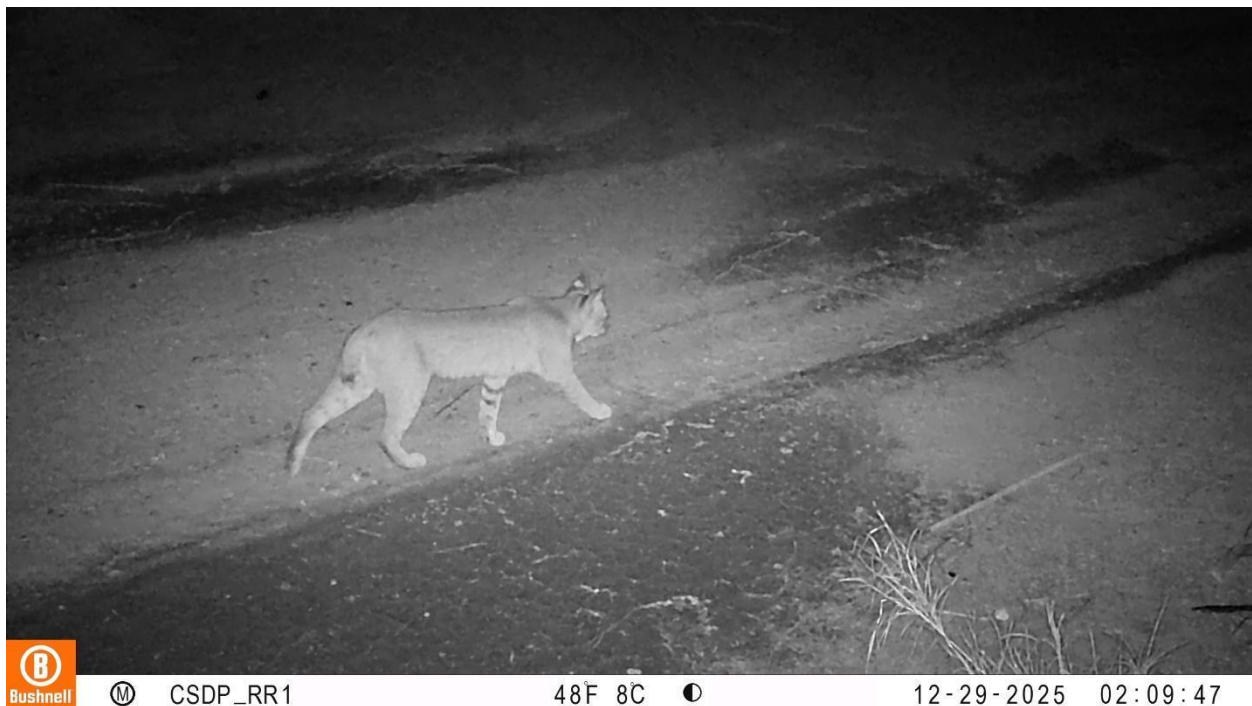
*Figure 6. A bobcat using the railroad underpass, headed west.*

In 2015, we began monitoring the railroad underpass and documented use by coyote, bobcat, and badger, despite the presence of vehicle barriers and the remains of several animal carcasses (deer, javelina and coyote primarily) dumped at the west entrance. We also documented sign of javelina using a canal culvert directly south of the railroad underpass to cross the highway. It is encouraging to see that some wildlife passage across I-10 is regularly occurring, although mostly by species that are most adaptable to the human-urban interface.

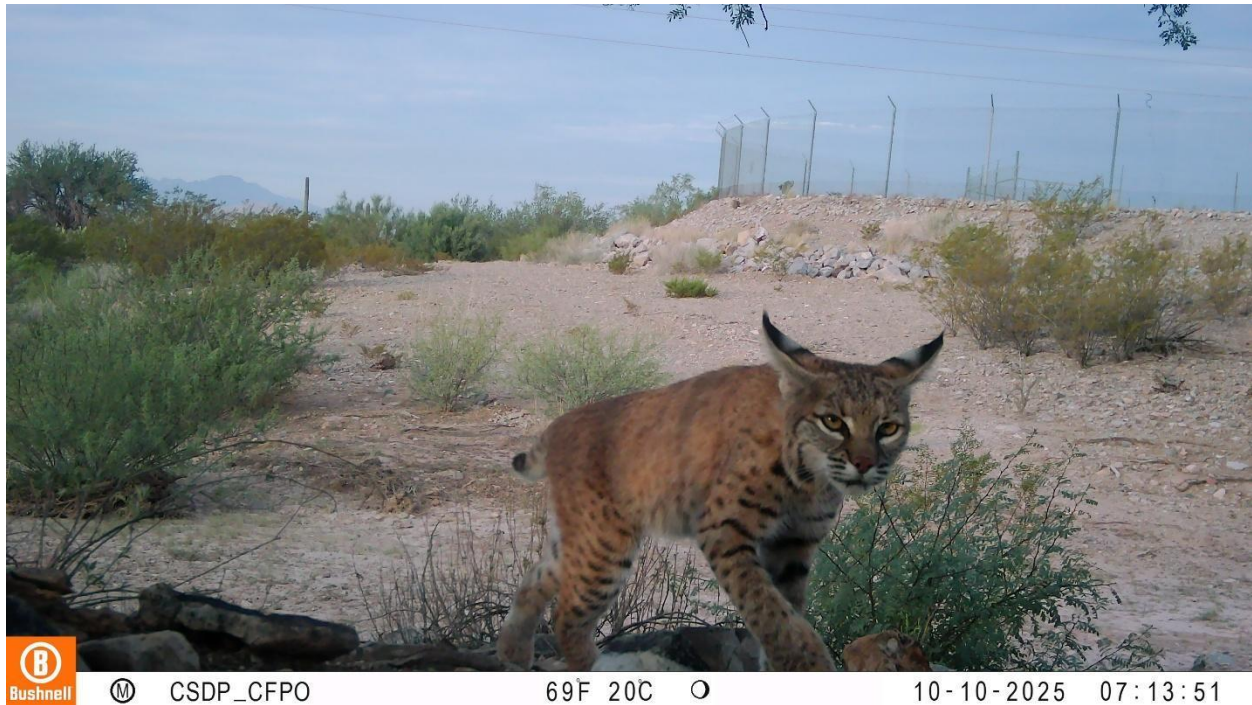
*Figure 8. A bobcat crosses a CAP canal wildlife siphon.*

CSDP also has three active cameras monitoring a critical CAP canal wildlife crossing feature west of the Tucson Mountains near Sinagua Rd. This data has been separated from the Tucson – Tortolita Mountain study, and we can report that to date these cameras have collected **2,274 verified wildlife photos over the course of 1,417 traps days, of over 23 species**. The most abundant have been ground birds, coyote, javelina, mule deer, bobcat, and domestic dog. In addition, a local resident has contributed over 5 years of wildlife camera data from her property, located adjacent to this CAP crossing, and we will be processing and incorporating this data as well in the coming year.
